SHOE NAIL 2637 1370.B. – HYPOEUTECTOID STEEL – ROMAN TIMES – SWITZERLAND

| Artefact name | Shoe nail 2637 1370.B. |
| Authors | Christian. Degriigny (HE-Arc CR, Neuchâtel, Neuchâtel, Switzerland) & Valentin. Boissonnas (HE-Arc CR, Neuchâtel, Neuchâtel, Switzerland) & Vincent Chappuis. (HE-Arc CR, Neuchâtel, Neuchâtel, Switzerland) |

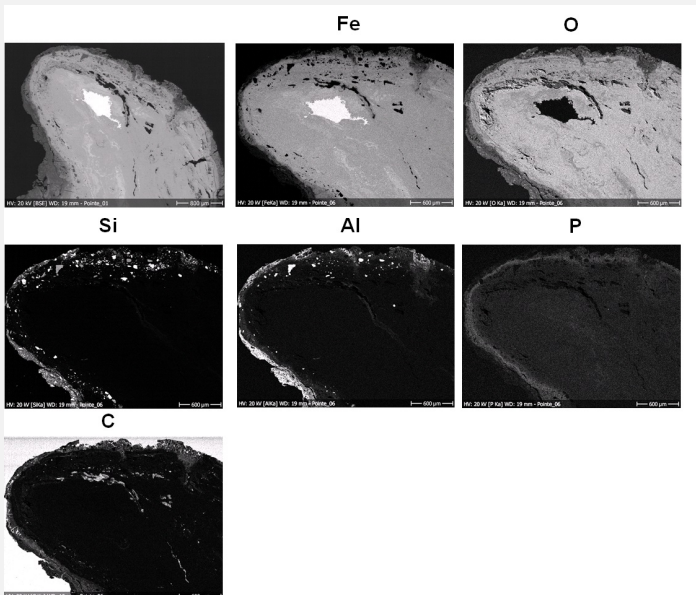
Si, Al, P and K can be considered external markers, helping to determine the limit of the original surface (Fig. 11 and Table 1). The outer layer of corrosion products (CP1-3) ranges from dark grey to orange in bright field and contains less O and Fe on its borders than the inner layer (CP4-5, Figs. 4 and 11, Table 1). The SEM pictures show a marbling appearance of the inner corrosion layer (CP5). Cl and S do not seem to be present in the sampled nail.

Fig. 11: Elemental chemical distribution of the selected area from Fig. 4 (90° counter-clockwise rotated). SEM-EDS,

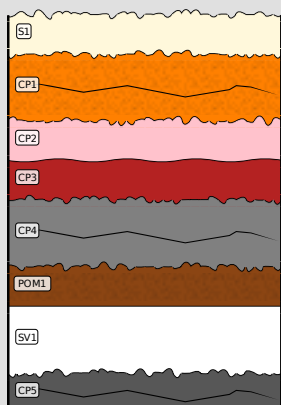
Fig. 12: Stratigraphic representation of the nail in cross-section (dark field) using the MiCorr application. The characteristics of the strata are only accessible by clicking on the drawing that redirects you to the search tool by stratigraphy representation. This representation can be compared to Fig. 14, Credit HE-Arc CR, V.Chappuis.

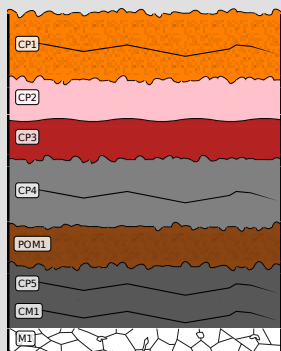
Fig. 13: Stratigraphic representation of the nail in cross-section (dark field) using the MiCorr application. The characteristics of the strata are only accessible by clicking on the drawing that redirects you to the search tool by stratigraphy representation. This representation can be compared to Fig. 14, Credit HE-Arc CR, V.Chappuis.
