HISPANO-SUIZA WATER PUMP – AL ALLOY – FRANCE

Artefact name	Hispano-Suiza water pump
Authors	Christian. Degriigny (HE-Arc CR, Neuchâtel, Neuchâtel, Switzerland) & Elodie. Granget (HE-Arc CR, Neuchâtel, Neuchâtel, Switzerland) & Brice. Chalançon (MNAM (Musée National de l'Automobile de Mulhouse), Mulhouse, Alsace, France)
Url	/artefacts/1250/

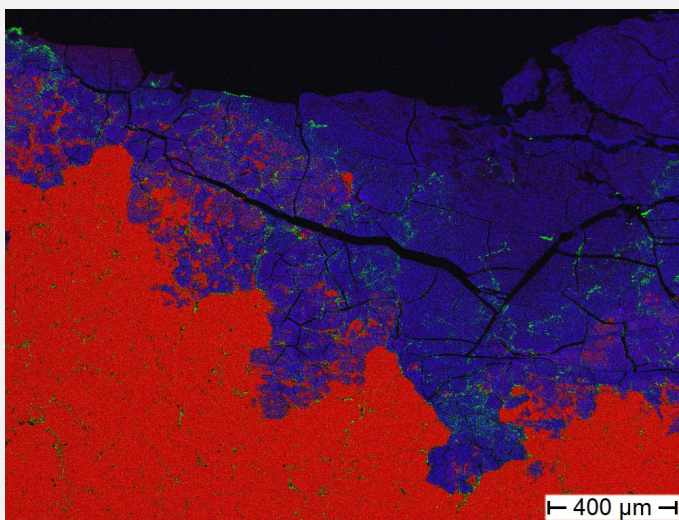
Local analyses on each phase appearing on Fig. 10 showed that the main phase is composed of Al and the interdendritic phases are composed of Al, Cu and Fe as well as Sn precipitates. This distribution is given through EDS elemental chemical distributions (Figs. 12 to 14).

Fig. 12: Al (red), O (blue) and Cu (green) distribution of the area of Fig. 11. Method of analysis: SEM-EDS. Lab. of Electronic Microscopy and Microanalysis, Néode, HEI Arc,

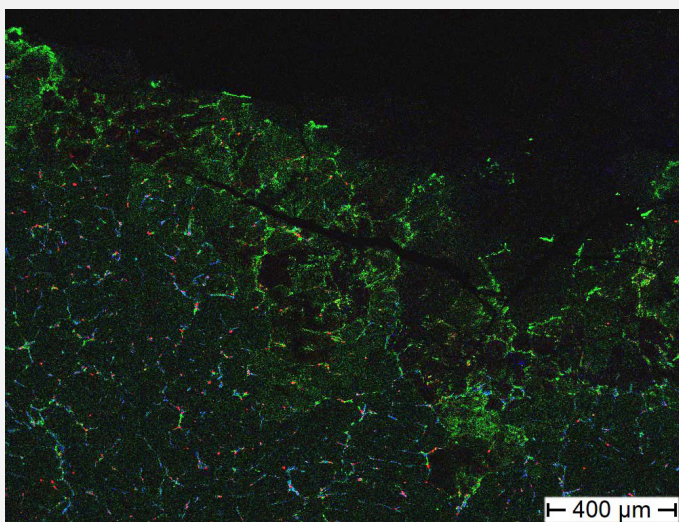
Fig. 13: Sn (red), Fe (blue) and Cu (green) distribution of the area of Fig. 11. Method of analysis: SEM-EDS. Lab. of Electronic Microscopy and Microanalysis, Néode, HEI Arc,

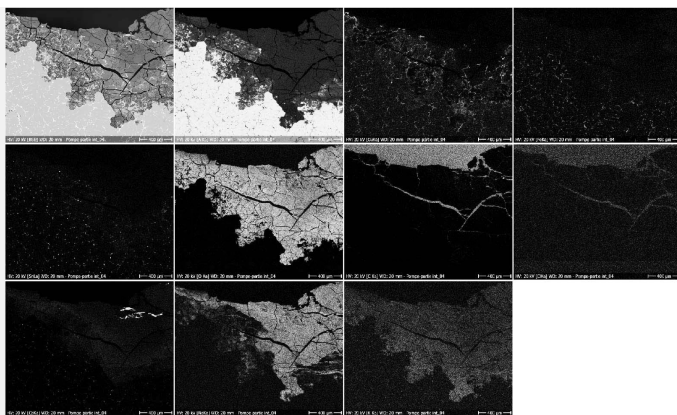
Fig. 14: SEM image and elemental chemical distribution of the area of Fig. 11. Method of analysis: SEM-EDS. Lab. of Electronic Microscopy and Microanalysis, Néode, HEI Arc,

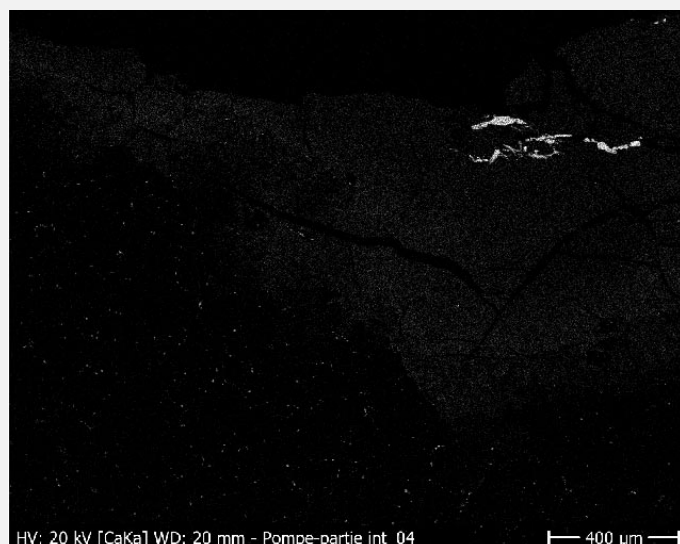
The SEM image of Fig. 11 clearly shows a network of cracks throughout CM1 and CPs. These cracks are not marking any clear separation between strata, but seem to affect all corrosion layers. The main Al phase is preferentially oxidized, while the interdendritic phase seems to be preserved in the corrosion products (Figs. 11 to 13). Na and K but no Fe are detected in the corrosion layers CM1 and CPs (Fig. 14). This surface is in contact with the coolant (glycol + additives, usually mixed 1/1 in water), which sometimes contain Na or K-based corrosion inhibitors. A cluster of CaCO₃ was identified on the very surface of the sample (Fig. 15). CaCO₃ can sometimes precipitate if the water used to mix the coolant is hard.

Fig. 15: Ca distribution of the area of Fig. 11. Method of analysis: SEM-EDS. Lab. of Electronic Microscopy and Microanalysis, Néode, HEI Arc,

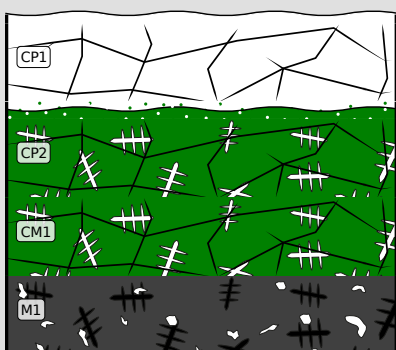
Fig. 16: Stratigraphic representation of the sample taken from the fastening part of the Hispano water pump in cross-section (dark field) using the MiCorr application. The characteristics of the strata are only accessible by clicking on the drawing that redirects you to the search tool by stratigraphy representation. This representation can be compared to Fig. 9, Credit HE-Arc CR, E.Granget.
