HISPANO-SUIZA WATER PUMP – AL ALLOY – FRANCE

Artefact name Hispano-Suiza water pump

Authors Christian. Degriigny (HE-Arc CR, Neuchâtel, Neuchâtel, Switzerland) & Elodie. Granget (HE-Arc CR, Neuchâtel, Neuchâtel, Switzerland) & Brice. Chalançon (MNAM (Musée National de l'Automobile de Mulhouse), Mulhouse, Alsace, France)

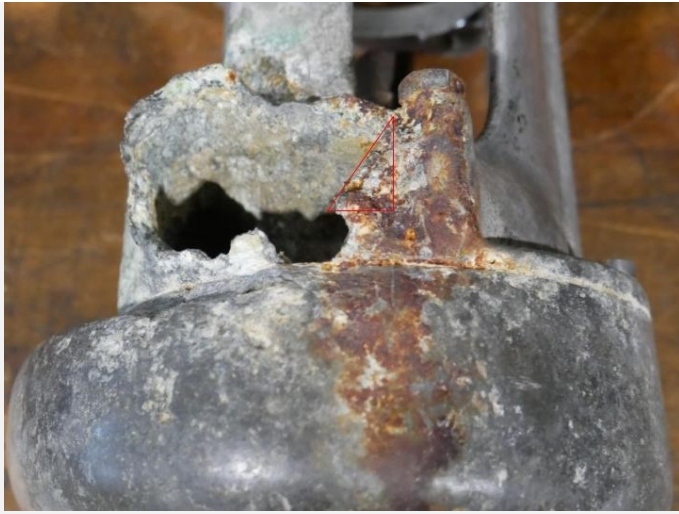
The exit pipe of the fastening part considered within this study is heavily corroded.

Fig. 3: Location of sampling area on the Hispano water pump,

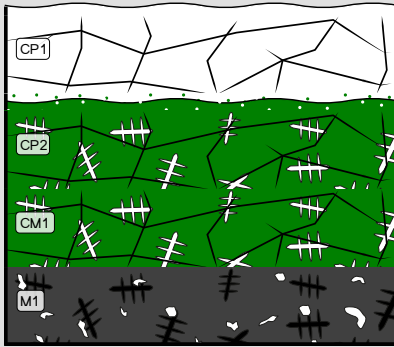
Fig. 16: Stratigraphic representation of the sample taken from the fastening part of the Hispano water pump in cross-section (dark field) using the MiCorr application. The characteristics of the strata are only accessible by clicking on the drawing that redirects you to the search tool by stratigraphy representation. This representation can be compared to Fig. 9, Credit HE-Arc CR, E.Granget.
