# BUGATTI 37 CYLINDER HEAD GASKET 0416 - AL ALLOY - MODERN TIMES - FRANCE

<b>Artefact name</b>	Bugatti 37 cylinder head gasket 0416
<b>Authors</b>	Christian. Degriigny (HE-Arc CR, Neuchâtel, Neuchâtel, Switzerland) & Elodie. Granget (HE-Arc CR, Neuchâtel, Neuchâtel, Switzerland) & Brice. Chalançon (MNAM (Musée National de l'Automobile de Mulhouse), Mulhouse, Alsace, France)
<b>Url</b>	/artefacts/1251/

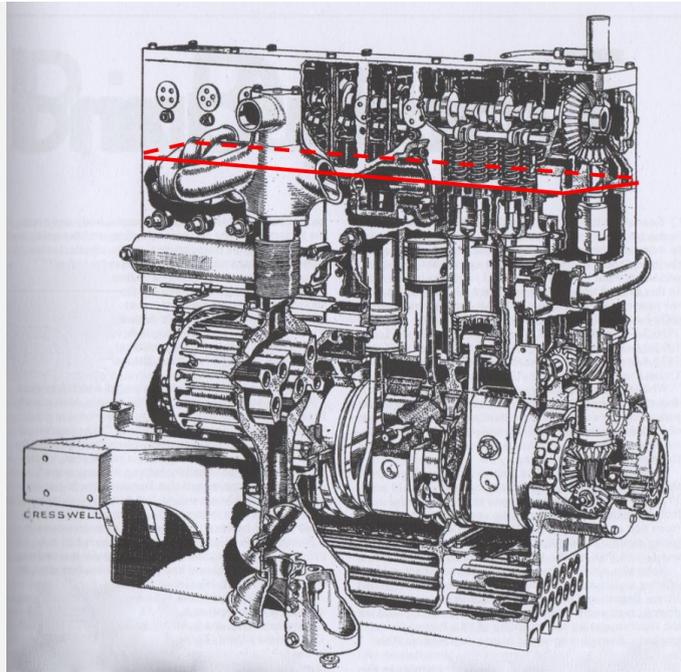
Fig. 2: Gasket located in red on technical drawing of the engine from Cresswell,

<b>Description of the artefact</b>	A coolant flows through the cylinder block inside galleries. This aluminium gasket is making a tight junction between the camshaft and the top of the block (Fig. 2). It keeps the water or coolant (water + glycol-based antifreeze) from mixing with the lubricant used on the shaft, the pistons and the cylinders. The wet side is facing the cylinder block. The other side is dry.
<b>Type of artefact</b>	Technical object
<b>Origin</b>	MNAM (Musée National de l'Automobile de Mulhouse), Mulhouse, Alsace, France
<b>Recovering date</b>	Unknown
<b>Chronology category</b>	Modern Times
<b>chronology tpq</b>	<input type="text" value="1926"/> A.D. ▾
<b>chronology taq</b>	<input type="text" value=""/> ---- ▾
<b>Chronology comment</b>	The production of this model started in 1926
<b>Burial conditions / environment</b>	Outdoor to indoor atmosphere
<b>Artefact location</b>	MNAM (Musée National de l'Automobile de Mulhouse), Mulhouse, Alsace

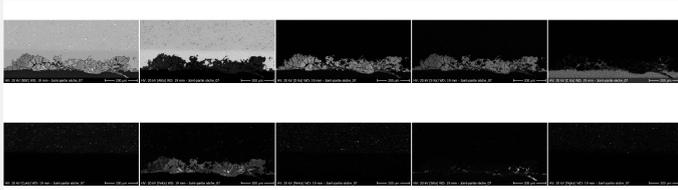
The EDS elemental chemical distribution of zone 1 is given in Fig. 11 to 13. The corrosion layers contain S (probably aluminium sulfate (Fig. 12), polluted with Fe (Fig. 11)). The presence of sulfur can be explained by the proximity of the gasket to the combustion chamber. As for the iron, it is probably coming from the steel block.

Fig. 13: SEM image and elemental chemical distribution of the area of Fig. 10. Method of analysis: SEM-EDS. Lab. of Electronic Microscopy and Microanalysis, Néode, HEI Arc.

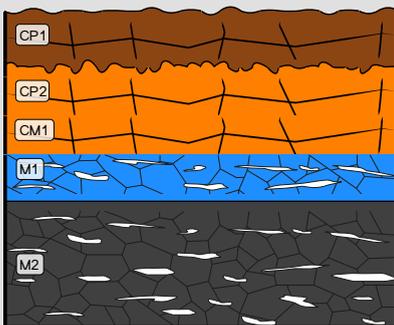
Fig. 14: Stratigraphic representation of the gasket (zone 1) in cross-section (dark field), using the MiCorr application. The characteristics of the strata are only accessible by clicking on the drawing that redirects you to the search tool by stratigraphy representation. This representation can be compared to Fig. 7, Credit HE-Arc CR, E.Granget.

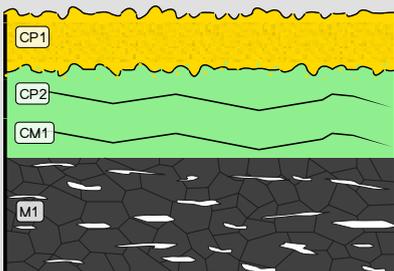
Fig. 15: Stratigraphic representation of the gasket (zone 2) in cross-section (dark field), using the MiCorr application. The characteristics of the strata are only accessible by clicking on the drawing that redirects you to the search tool by stratigraphy representation. This representation can be compared to Fig. 9, Credit HE-Arc CR, E.Granget.
