## BUGATTI COOLING SYSTEM PIPE – AL ALLOY – UNKNOWN – FRANCE

**Artefact name** Bugatti cooling system pipe

**Authors** Christian. Degriigny (HE-Arc CR, Neuchâtel, Neuchâtel, Switzerland) & Elodie. Granget (HE-Arc CR, Neuchâtel, Neuchâtel, Switzerland) & Brice. Chalauçon (MNAM (Musée National de l'Automobile de Mulhouse), Mulhouse, Alsace, France)

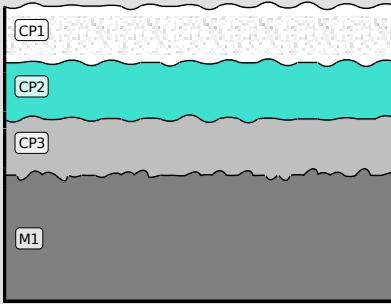
The stratum M is an aluminium alloy. Three CP strata have been identified. CP3 has a greyish mate color and is covering all of the corroded side of the pipe. Scattered over this uniform layer, blue-green (CP2) and white (CP1) spots of corrosion products can be found.

Fig. 5: Stratigraphic representation of the corrosion structure of the Bugatti water pipe observed macroscopically under binocular microscope using the MiCorr application. The characteristics of the strata are only accessible by clicking on the drawing that redirects you to the search tool by stratigraphy representation. This representation can be compared to Fig. 4, Credit HE-Arc CR, E.Granget.

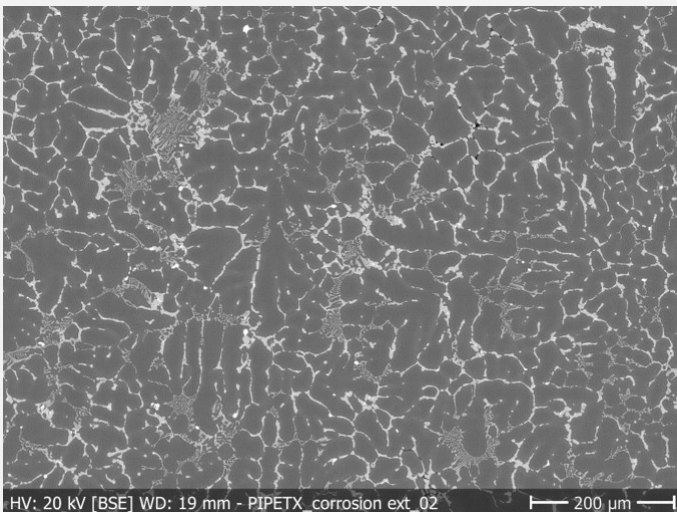
The metal is an aluminium alloy containing both Cu and Zn. It is slightly porous (Fig. 7, red circles). Its dendritic microstructure is revealed by observation in bright field (Fig. 8) and with SEM (Fig. 9).

Fig. 8: Micrograph similar to Fig. 7, unetched, bright field showing the locations of Fig. 9 (in red) and Fig. 10 (in blue),

The BF and DF images (Figs. 7 and 8) show a few big cracks at the interface between CM1 and M1. The SEM image shows that they expand in a network of additional microcracks (Fig. 13). The pipe suffers from a uniform interdendritic corrosion. The Al, Cu and Zn phase is oxidising preferentially, developing then aluminium oxides, versus the interdendritic phases. In some places, pits of corrosion formed. SEM cartography showed a concentration of Cl at the base of the pit (Fig. 14: Green).

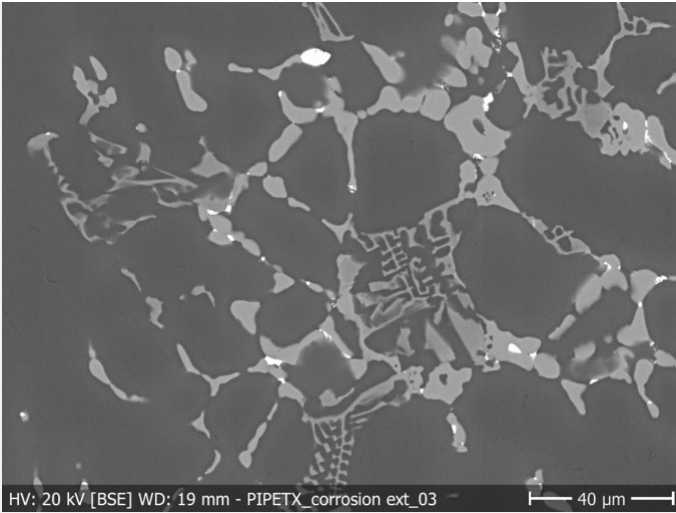
Fig. 9: SEM image (BSE mode) of the metal sample from Fig. 8 showing the microstructure of the pipe. Dark grey = main phase (Al), medium grey = interdendritic phase 1 (eutectic Al, Fe, Cu), light grey = interdendritic phase 2 (Al, Cu) and white = precipitates (Si, Sn),

This angled water pipe, coming from a Bugatti engine's cooling system, is made of cast Al, Cu, Zn, Fe alloy and shows a slightly porous dendritic microstructure. There are two interdendritic phases, a eutectic Al, Fe, Cu phase and a Al, Cu phase, as well as precipitates of Si and Sn.

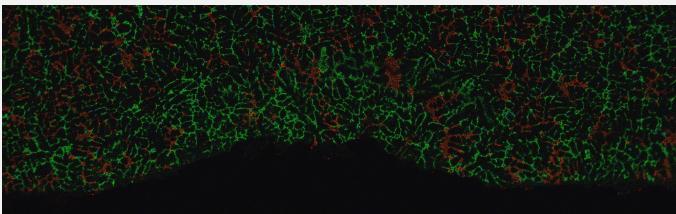
Fig. 11: SEM image and EDS elemental chemical distribution of main and interdendritic phases of the pipe. 20kV,

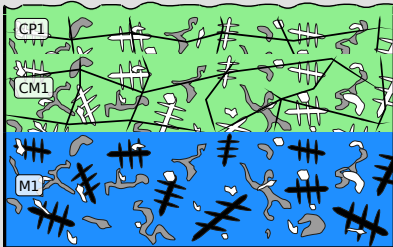
Fig. 14: Stratigraphic representation of the sample taken from the Bugatti water pipe in cross-section (dark field) using the MiCorr application. The characteristics of the strata are only accessible by clicking on the drawing that redirects you to the search tool by stratigraphy representation. This representation can be compared to Fig. 7 and 8, Credit HE-Arc CR, E.Granget.
