## BUGATTI COOLING SYSTEM PIPE – AL ALLOY – UNKNOWN – FRANCE

**Artefact name** Bugatti cooling system pipe

**Authors** Christian. Degriigny (HE-Arc CR, Neuchâtel, Neuchâtel, Switzerland) & Elodie. Granget (HE-Arc CR, Neuchâtel, Neuchâtel, Switzerland) & Brice. Chalançon (MNAM (Musée National de l'Automobile de Mulhouse), Mulhouse, Alsace, France)

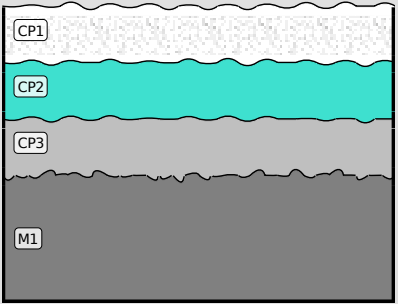
The stratum M is an aluminium alloy. Three CP strata have been identified. CP3 has a greyish mate color and is covering all of the corroded side of the pipe. Scattered over this uniform layer, blue-green (CP2) and white (CP1) spots of corrosion products can be found.

Fig. 5: Stratigraphic representation of the corrosion structure of the Bugatti water pipe observed macroscopically under binocular microscope using the MiCorr application. The characteristics of the strata are only accessible by clicking on the drawing that redirects you to the search tool by stratigraphy representation. This representation can be compared to Fig. 4, Credit HE-Arc CR, E.Granget.

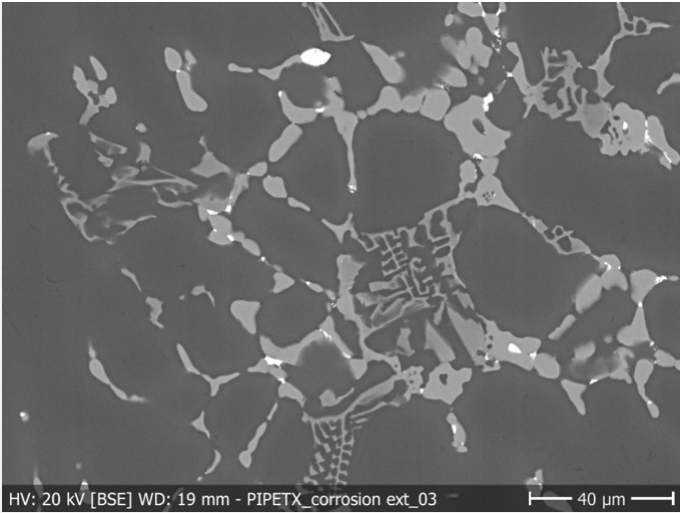
Fig. 10: Close-up image of Fig. 9,

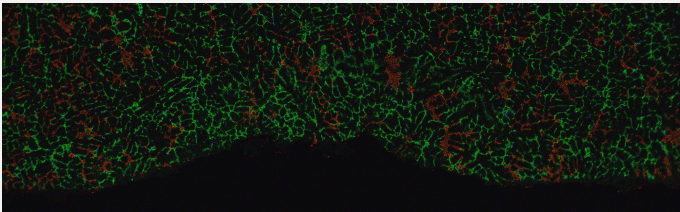
Fig. 11: SEM image and EDS elemental chemical distribution of main and interdendritic phases of the pipe. 20kV,

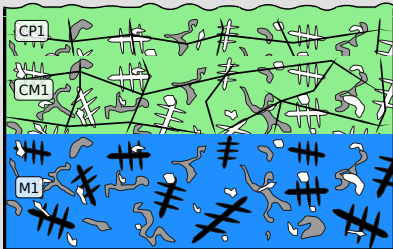
The BF and DF images (Figs. 7 and 8) show a few big cracks at the interface between CM1 and M1. The SEM image shows that they expand in a network of additional microcracks (Fig. 13). The pipe suffers from a uniform interdendritic corrosion. The Al, Cu and Zn phase is oxidising preferentially, developing then aluminium oxides, versus the interdendritic phases. In some places, pits of corrosion formed. SEM cartography showed a concentration of Cl at the base of the pit (Fig. 14: Green).

Fig. 14: Stratigraphic representation of the sample taken from the Bugatti water pipe in cross-section (dark field) using the MiCorr application. The characteristics of the strata are only accessible by clicking on the drawing that redirects you to the search tool by stratigraphy representation. This representation can be compared to Fig. 7 and 8, Credit HE-Arc CR, E.Granget.

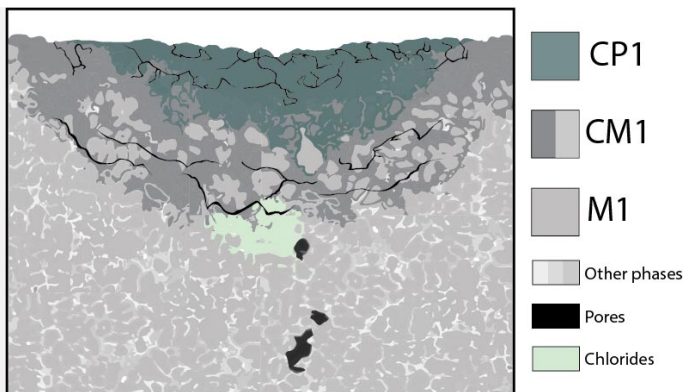
The schematic representation of corrosion layers of Fig. 4 integrating additional information based on the analyses carried out is given in Fig. 15.

Fig. 15: Improved stratigraphic representation of the exit pipe,
