# FUNERAL MASK IVC 11595 – CU/AG, WITH SURFACE ENRICHMENT (AG) – UNKNOWN

Artefact name	Funeral mask IVC 11595
Authors	Christian. Degryny (HE-Arc CR, Neuchâtel, Neuchâtel, Switzerland) & Naima. Gutknecht (HE-Arc CR, Neuchâtel, Neuchâtel, Switzerland) & Valentin. Boissonnas (HE-Arc CR, Neuchâtel, Neuchâtel, Switzerland)
Url	/artefacts/1262/

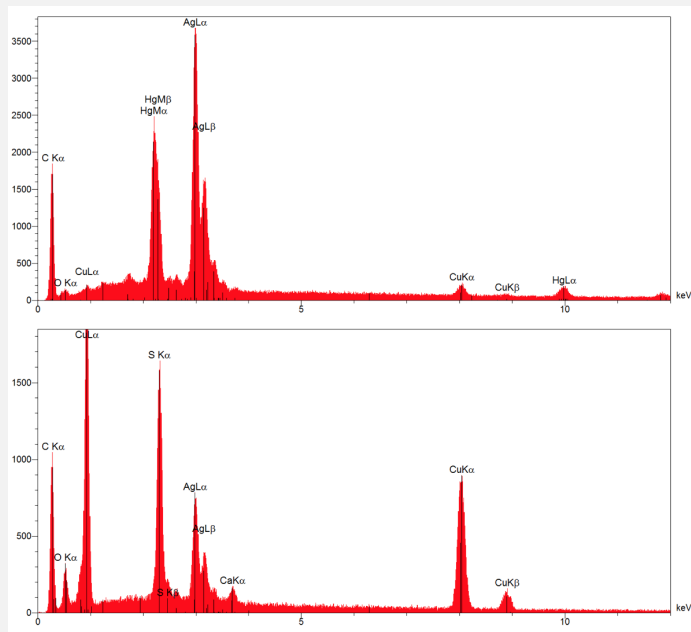
The silver enriched surface is entirely covered with copper corrosion products. The outer green layer (CP1) is a copper carbonate (Fig. 11, Table 1), while the red layers (CP2 in Fig. 15 ; CP4 and CP5 in Fig. 16) are consisting of a copper oxide, most likely cuprite (Fig. 9). Below the cuprite and above the silver enriched surface on the front face a thin black layer is present (appears grey under polarized light). SEM-EDS analysis shows that in that stratum the mercury of the pigment (Fig. 14) has been transformed into a mercury-silver compound (Figs. 7 and 10) which according to Raman spectrometry (Fig. 14) is not cinnabar anymore. In areas this silver- and mercury-rich surface has been pulled off by raising the corrosion layers, leaving structural voids that were subsequently filled by secondary corrosion products, most likely copper carbonates (Figs. 6 and 7).

Fig. 9: EDS analysis of the red corrosion layer (Fig. 4). Method of analysis: SEM-EDS, Lab of Electronic Microscopy and Microanalysis, IMA (Néode), HEI Arc,

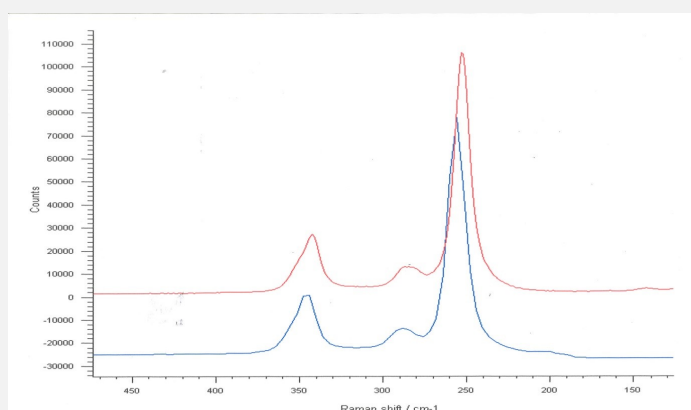
The silver sulphide (HgS, cinnabar, Fig. 13), present as a red pigment on the silver surface, could have been reduced through an electrochemical process in the presence of chlorides (Keune 2005). The released sulfur recombined with the silver to form black silver sulphide. Above that layer a porous mercury- and silver rich stratum has formed (see Hg & Ag on cartography Fig. 8). It remains unclear if the limitos is located in the silver enriched surface or within this silver-mercury compound (Fig. 7).

Fig. 13: Raman analysis of the red pigment on the surface (red line) and the references for cinnabar (blue line). Method of analysis: Raman spectroscopy, HKB,

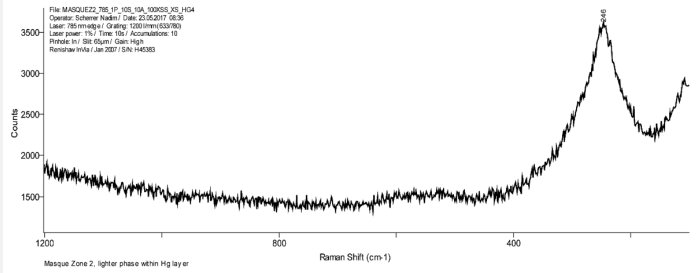
Fig. 14: Raman analysis of the mercury compounds from the cross section. Method of analysis: Raman spectroscopy, HKB,
