FUNERAL MASK IVC 11595 – CU/AG, WITH SURFACE ENRICHMENT (AG) – UNKNOWN

Artefact name	Funeral mask IVC 11595
Authors	Christian. Degriy (HE-Arc CR, Neuchâtel, Neuchâtel, Switzerland) & Naima. Gutknecht (HE-Arc CR, Neuchâtel, Neuchâtel, Switzerland) & Valentin. Boissonnas (HE-Arc CR, Neuchâtel, Neuchâtel, Switzerland)
Url	/artefacts/1262/

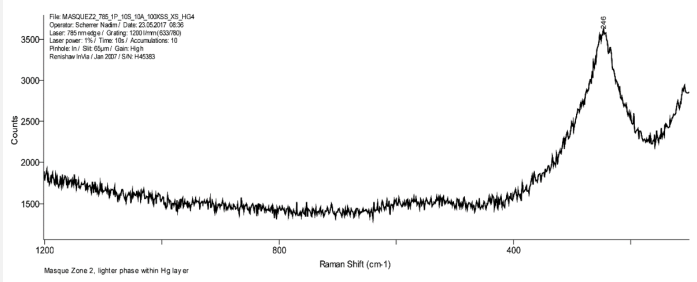
Fig. 14: Raman analysis of the mercury compounds from the cross section. Method of analysis: Raman spectroscopy, HKB,
