# LEAD CAMES OF A STAINED GLASS WINDOW 52583 – PB SB ALLOY – UNKNOWN – SWITZERLAND

**Artefact name** Lead comes of a stained glass window 52583

**Authors** Alice Gerber. (Haute École Arc Neuchâtel, Neuchâtel, Neuchâtel, Switzerland)

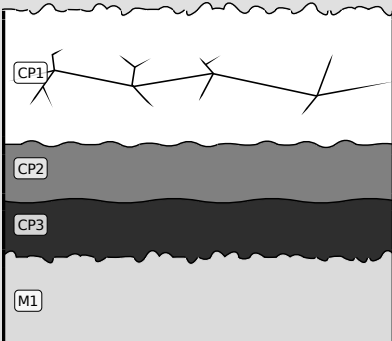
Fig. 4: Stratigraphic representation of the corrosion structure of the lead came observed macroscopically under binocular microscope using the MiCorr application. The characteristics of the strata are only accessible by clicking on the drawing that redirects you to the search tool by stratigraphy representation, Credit HE-Arc CR, A.Gerber.

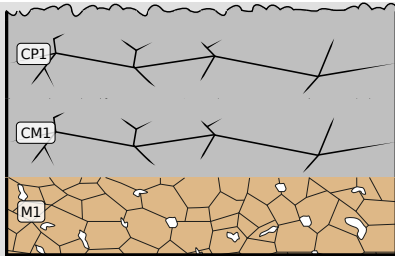
Corrosion develops specifically on comes made of a lead-antimony alloy, where antimony inclusions constitute the cathode (0.150 V/SHE) versus lead (-0.125 V/SHE) which corrodes as an anode in presence of lead acetate (the electrolyte). Fig. 8 shows that corrosion does not attack the antimony nodules in the alloy, it progresses by mineralizing the lead around these nodules.

Fig. 10: Stratigraphic representation of the lead came in cross-section (dark field) using the MiCorr application with

reference to Fig. 8. The characteristics of the strata are only accessible by clicking on the drawing that redirects you to the search tool by stratigraphy representation, Credit HE-Arc CR, A.Gerber.
