LEAD CAMES OF A STAINED GLASS WINDOW 52583 – PB SB ALLOY – UNKNOWN – SWITZERLAND

Artefact name Lead comes of a stained glass window 52583

Authors Alice Gerber. (Haute École Arc Neuchâtel, Neuchâtel, Neuchâtel, Switzerland)

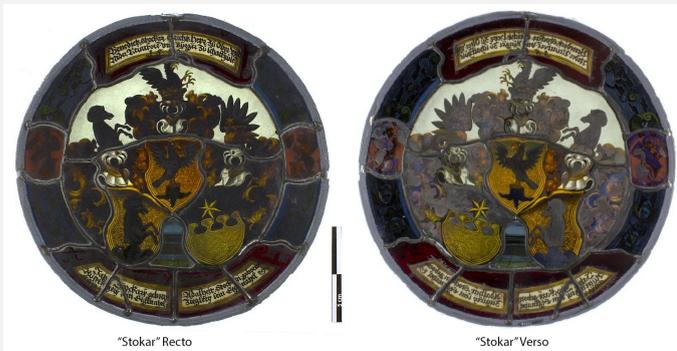
Fig. 1: Stained glass panel "Stokar" both sides,

In 2009 two stained glass panels were placed in a showcase for a permanent exhibition, the lead came were then in a good conservation condition. In 2018, the lead showed voluminous efflorescence of white, powdery corrosion products.

The "stokar" window, which is of interest here, was restored in 2008, just before it was put on display. The restoration consisted of replacing some of the lead came. Thus, while the object is dated to the 16th century, the replaced came were new when they entered the display case. In 2018, they were completely corroded. In comparison, the other stained glass panel, with older lead came, was placed in the same display case at the same time. For this second panel, the came are slightly corroded in 2018, but not as badly as those of the 'Stokar' panel. The metal chosen by the restorer reacted more strongly with the corrosive environment (the display case) than the historical metal.

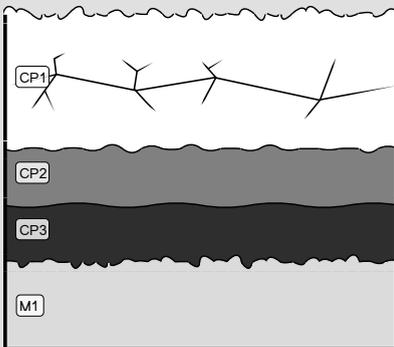
Fig. 4: Stratigraphic representation of the corrosion structure of the lead came observed macroscopically under binocular microscope using the MiCorr application. The characteristics of the strata are only accessible by clicking on the drawing that redirects you to the search tool by stratigraphy representation, Credit HE-Arc CR, A.Gerber.

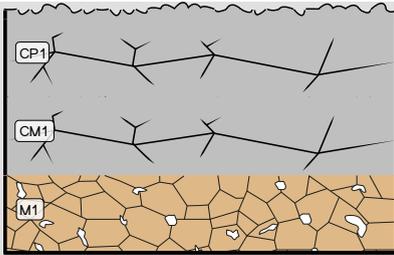
Corrosion develops specifically on comes made of a lead-antimony alloy, where antimony inclusions constitute the cathode (0.150 V/SHE) versus lead (-0.125 V/SHE) which corrodes as an anode in presence of lead acetate (the electrolyte). Fig. 8 shows that corrosion does not attack the antimony nodules in the alloy, it progresses by mineralizing the lead around these nodules.

CP1 seems to be a heterogeneous compound as indicated on Figs. 8 and 9. It is heavily cracked (Fig. 9). EDX analyses do not indicate a significant difference in composition. The attack of lead by organic acids causes the formation of salts, such as lead acetate which are then transformed into basic lead carbonates by the action of CO₂ from the environment as indicated by FTIR analysis of CP1.

Fig. 10: Stratigraphic representation of the lead came in cross-section (dark field) using the MiCorr application with reference to Fig. 8. The characteristics of the strata are only accessible by clicking on the drawing that redirects you to the search tool by stratigraphy representation, Credit HE-Arc CR, A.Gerber.
