LEAD CAMES OF A STAINED GLASS WINDOW 52583 – PB SB ALLOY – UNKNOWN – SWITZERLAND

Artefact name Lead comes of a stained glass window 52583

Authors Alice Gerber. (Haute École Arc Neuchâtel, Neuchâtel, Neuchâtel, Switzerland)

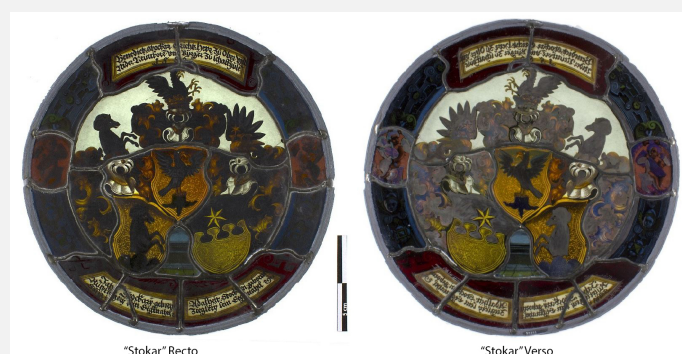
Fig. 1: Stained glass panel "Stokar" both sides,

In 2009 two stained glass panels were placed in a showcase for a permanent exhibition, the lead came were then in a good conservation condition. In 2018, the lead showed voluminous efflorescence of white, powdery corrosion products.

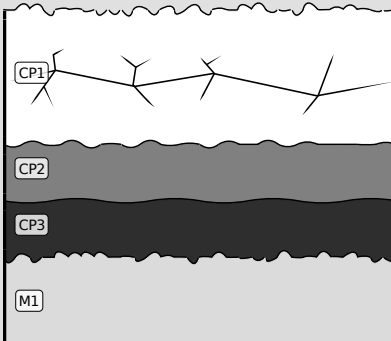
Fig. 4: Stratigraphic representation of the corrosion structure of the lead came observed macroscopically under binocular microscope using the MiCorr application. The characteristics of the strata are only accessible by clicking on the drawing that redirects you to the search tool by stratigraphy representation, Credit HE-Arc CR, A.Gerber.

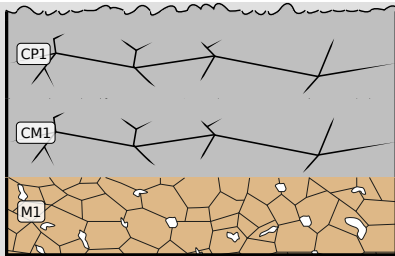
Corrosion develops specifically on comes made of a lead-antimony alloy, where antimony inclusions constitute the cathode (0.150 V/SHE) versus lead (-0.125 V/SHE) which corrodes as an anode in presence of lead acetate (the electrolyte). Fig. 8 shows that corrosion does not attack the antimony nodules in the alloy, it progresses by mineralizing the lead around these nodules.

CP1 seems to be an heterogeneous compound as indicated on Figs. 8 and 9. It is heavily cracked (Fig. 9). EDX analyses do not indicate a significant difference in composition. The attack of lead by organic acids causes the formation of salts, such as lead acetate which are then transformed into basic lead carbonates by the action of CO2 from the environment as indicated by FTIR analysis of CP1.

Fig. 10: Stratigraphic representation of the lead came in cross-section (dark field) using the MiCorr application with

reference to Fig. 8. The characteristics of the strata are only accessible by clicking on the drawing that redirects you to the search tool by stratigraphy representation, Credit HE-Arc CR, A.Gerber.
