# LEAD CAMES OF A STAINED GLASS WINDOW 52583 – PB SB ALLOY – UNKNOWN – SWITZERLAND

**Artefact name** Lead comes of a stained glass window 52583

**Authors** Alice Gerber. (Haute École Arc Neuchâtel, Neuchâtel, Neuchâtel, Switzerland)

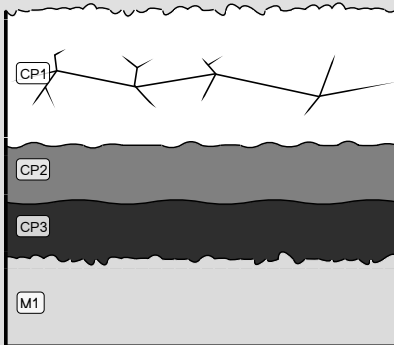
Fig. 4: Stratigraphic representation of the corrosion structure of the lead came observed macroscopically under binocular microscope using the MiCorr application. The characteristics of the strata are only accessible by clicking on the drawing that redirects you to the search tool by stratigraphy representation, Credit HE-Arc CR, A.Gerber.

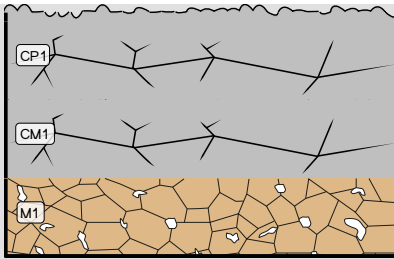
Corrosion develops specifically on comes made of a lead-antimony alloy, where antimony inclusions constitute the cathode (0.150 V/SHE) versus lead (-0.125 V/SHE) which corrodes as an anode in presence of lead acetate (the electrolyte). Fig. 8 shows that corrosion does not attack the antimony nodules in the alloy, it progresses by mineralizing the lead around these nodules.

Fig. 10: Stratigraphic representation of the lead came in cross-section (dark field) using the MiCorr application with reference to Fig. 8. The characteristics of the strata are only accessible by clicking on the drawing that redirects you to the search tool by stratigraphy representation, Credit HE-Arc CR, A.Gerber.
