FRAGMENT OF AN AEGIS OF NEÏTH 1886.305.0096 – LEADED BRONZE

Artefact name	Fragment of an Aegis of Neïth 1886.305.0096
Authors	Line. Pedersen (HE-Arc, Neuchâtel, Neuchâtel, Switzerland) & Christian. Degriigny (HE-Arc CR, Neuchâtel, Neuchâtel, Switzerland) & Valentin. Boissonnas (HE-Arc CR, Neuchâtel, Neuchâtel, Switzerland)
Url	/artefacts/1270/

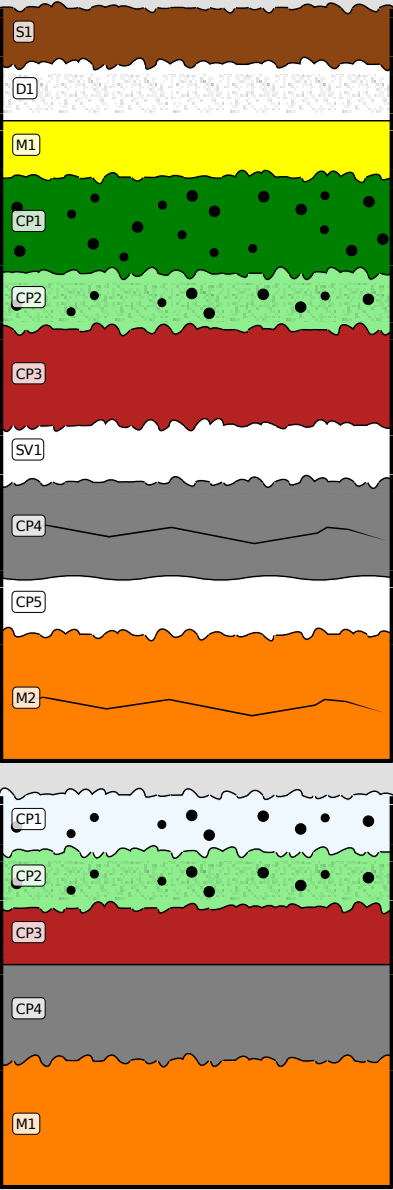
Fig.9: Schematic representation combining stratigraphies 1 and 2 under binocular microscope and using the MiCorr application. The characteristics of the strata are only accessible by clicking on the drawing that redirects you to the search tool by stratigraphy representation, Credit He-Arc CR, L.Pedersen.

The metal (M2 in Fig.9 and M1 in Fig. 10) was analysed on the broken edge of the bottom of the artefact where despite a highly corroded surface, the metal seems to be the best preserved. The XRF analyses revealed that the metal is a leaded bronze with remains of gold leaf on the surface (Table 1, Au was detected in the measurement spots 4,5 and 6) (Scott 2002; Gouda 2012; Mohammed 2012).
