ANTHROPOMORPHIC VASE – AG ALLOY – ROMAN TIMES

Artefact name Anthropomorphic vase

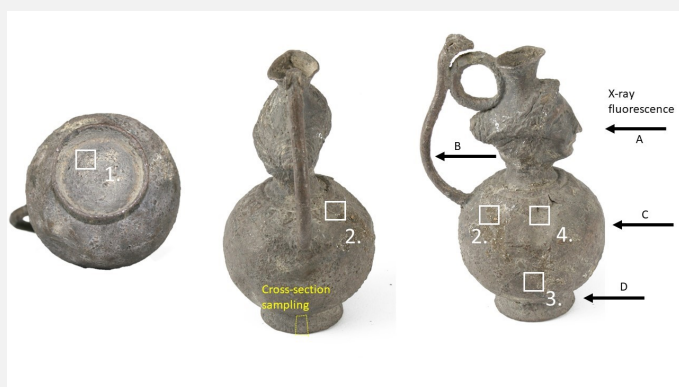
Fig. 2: Locations of the four points analysed with X-ray fluorescence (black arrows A-D), the four samples (numbers 1-4) and the cross-section (yellow) analysed with SEM-EDS,

The XRF analysis of the vase was carried out before sampling on four areas (Fig. 2). During the analysis, the layers of soil, corrosion and metal are analysed at the same time. The metal is probably a silver alloy with a small amount of Cu (and possibly Bi?). Some of the other elements detected are part of the burial environment (Al, Si, Fe, Cr) and corrosion products (Br, Cl). Titanium is probably an artefact.

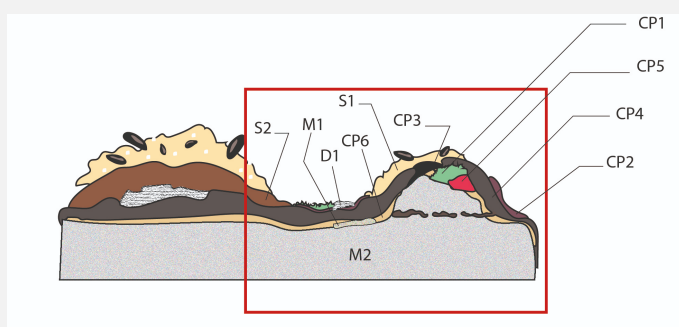
Strata	Type of Stratum	Principal Characteristics
S1	Soil (with mica / feldspath)	light beige, medium, non-compact, powdery and containing black-brown scattered aggregates
S2	Soil	brown, medium, compact, very soft
D1	Deposit	white, thin, compact, hard, brittle
CP1	Corroded product	light green, thin, discontinuous, non-compact, powdery
CP2	Corroded product	pinkish brown, thin, discontinuous, compact, soft
CP3	Corroded product	black, medium, discontinuous, compact, hard
CP4	Corroded product	dark brown, medium, continuous, compact, soft
CP5	Corroded product	red, thin, discontinuous, non-compact, powdery, soft
CP6	Corroded product	light beige, thin, continuous, compact, very soft
M1	Metal	yellowish grey, metallic, hard
M2	Metal	grey-white, metallic, soft

Fig. 3: Stratigraphic representation of the corrosion structure of the vase by macroscopic and binocular observation with indication of the corrosion structure used to build the MiCorr stratigraphy of Fig. 4 (red rectangle),

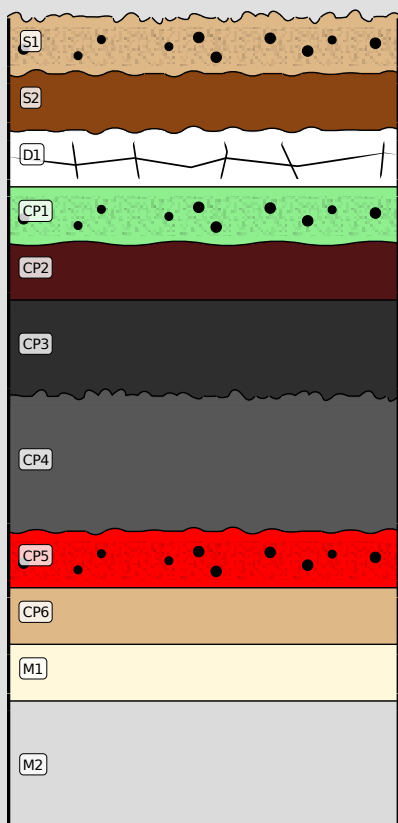
Fig. 4: Stratigraphic representation of the corrosion structure of the vase observed macroscopically under binocular microscope using the MiCorr application with reference to Fig. 3. The characteristics of the strata are only accessible by clicking on the drawing that redirects you to the search tool by stratigraphy representation, credit HE-Arc CR, S.Béguelin.

Compared with Figure 4, the amount of information is just limited to an area where there is only one blister. Observation of the cross-section did not reveal all the corrosion layers visible on the entire object when it was probed under binoculars. In fact, only two layers of corrosion are visible (CP1 and CP2) (Fig. 19). They correspond to two different corrosion layers of the Bi MiCorr stratigraphy (CP2 and CP4, Fig. 4). CM1 (Fig.19) could correspond to CP6 and M1 on Fig. 4. M2 on Fig. 4 corresponds to M1 on Fig. 19.

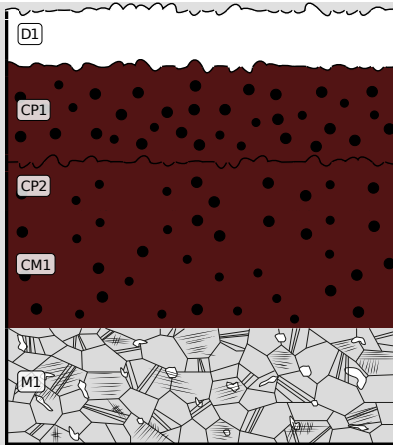
Fig. 19: Stratigraphic representation of the sample of the vase observed in cross-section under dark field using the MiCorr application. The characteristics of the strata are only accessible by clicking on the drawing that redirects you to the search tool by stratigraphy representation. This

representation was build according to Fig.15, credit HE-Arc CR, S.Béguelin.

The lack of information when examining the cross-section is due to the fact that the colours of the layers are very close to each other. The sample is fairly representative of the object, showing mainly a layer of corrosion rich in Ag, Cl and Br on a metal that is subject to intergranular corrosion. The sample's location was chosen because it's a discrete area and it allowed us to analyse the metal at its core.

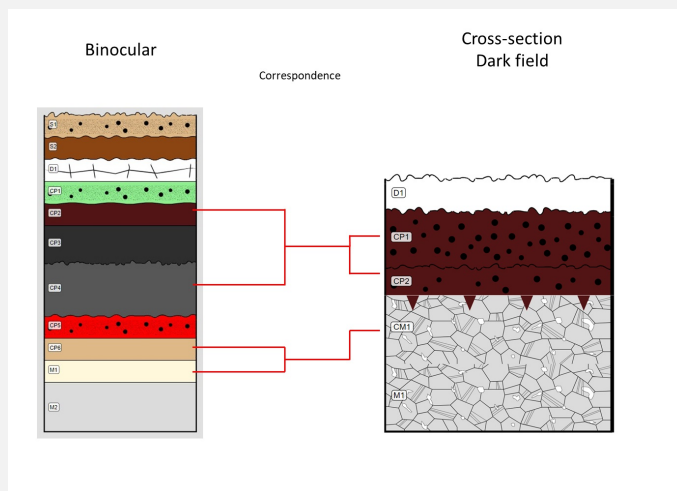
Fig. 20: Stratigraphic representation side by side of binocular view and cross-section (dark field),

The limit of the original surface (limitos) could not be located precisely but it certainly within the silver-based corrosion products.
