ANTHROPOMORPHIC VASE – AG ALLOY – ROMAN TIMES

Artefact name Anthropomorphic vase

Authors (HE-Arc CR, Neuchâtel, Neuchâtel, Switzerland). (Christian Degriigny, None) & Solène. Béguelin (HE-Arc CR, Neuchâtel, Neuchâtel, Switzerland) & Valentin. Boissonnas (HE-Arc CR, Neuchâtel, Neuchâtel, Switzerland)

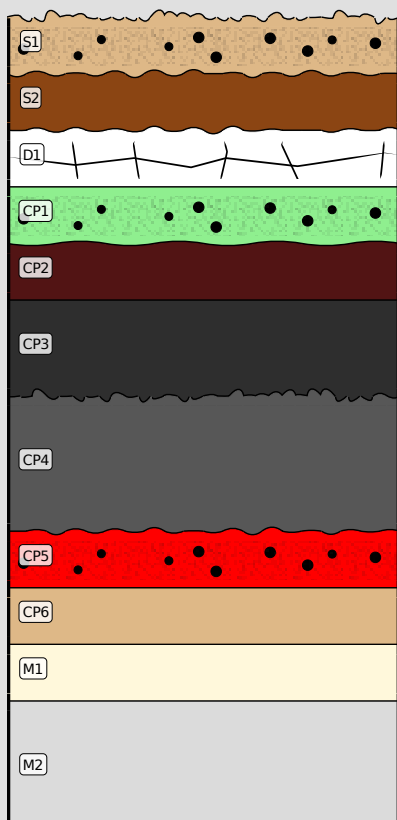
Fig. 4: Stratigraphic representation of the corrosion structure of the vase observed macroscopically under binocular microscope using the MiCorr application with reference to Fig. 3. The characteristics of the strata are only accessible by clicking on the drawing that redirects you to the search tool by stratigraphy representation, credit HE-Arc CR, S.Béguelin.

Compared with Figure 4, the amount of information is just limited to an area where there is only one blister. Observation of the cross-section did not reveal all the corrosion layers visible on the entire object when it was probed under binoculars. In fact, only two layers of corrosion are visible (CP1 and CP2) (Fig. 19). They correspond to two different corrosion layers of the Bi MiCorr stratigraphy (CP2 and CP4, Fig. 4). CM1 (Fig.19) could correspond to CP6 and M1 on Fig. 4. M2 on Fig. 4 corresponds to M1 on Fig. 19.

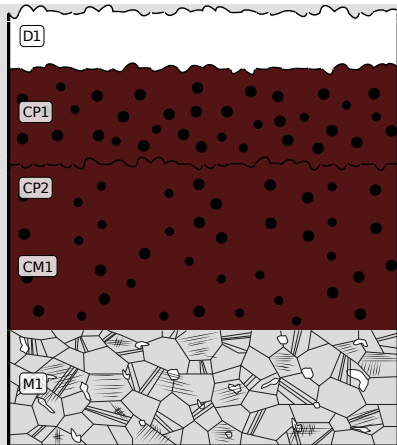
Fig. 19: Stratigraphic representation of the sample of the vase observed in cross-section under dark field using the MiCorr application. The characteristics of the strata are only accessible by clicking on the drawing that redirects you to the search tool by stratigraphy representation. This

representation was build according to Fig.15, credit HE-Arc CR, S.Béguelin.
