ANTHROPOMORPHIC VASE - AG ALLOY - ROMAN TIMES

Artefact name Anthropomorphic vase

Authors (HE-Arc CR, Neuchâtel, Neuchâtel, Switzerland). (Christian Degrigny, None) & Solène. Béguelin (HE-Arc CR, Neuchâtel, Neuchâtel, Switzerland) & Valentin. Boissonnas (HE-Arc CR, Neuchâtel, Neuchâtel, Switzerland)

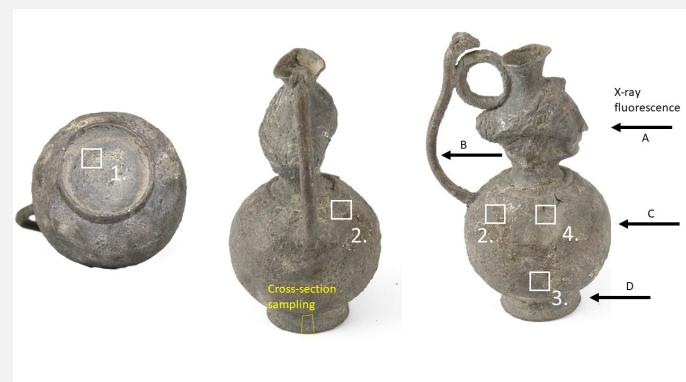
Fig. 2: Locations of the four points analysed with X-ray fluorescence (black arrows A-D), the four samples (numbers 1-4) and the cross-section (yellow) analysed with SEM-EDS,

Samples 1-4 were taken from different areas of the object (Fig. 2) using a scalpel; they were not embedded.

The cross-section embedded corresponds to a transversal cut made on the foot of the container (Fig. 2). A metallic core is present below the corrosion layers (Fig. 9).

The XRF analysis of the vase was carried out before sampling on four areas (Fig. 2). During the analysis, the layers of soil, corrosion and metal are analysed at the same time. The metal is probably a silver alloy with a small amount of Cu (and possibly Bi?). Some of the other elements detected are part of the burial environment (Al, Si, Fe, Cr) and corrosion products (Br, Cl). Titanium is probably an artefact.

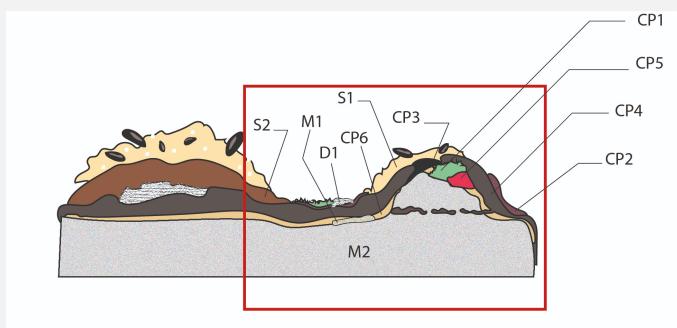
Strata	Type of Stratum	Principal Characteristics
S1	Soil (with mica / feldspath)	light beige, medium, non-compact, powdery and containing black-brown scattered aggregates
S2	Soil	brown, medium, compact, very soft
D1	Deposit	white, thin, compact, hard, brittle
CP1	Corroded product	light green, thin, discontinuous, non-compact, powdery
CP2	Corroded product	pinkish brown, thin, discontinuous, compact, soft
CP3	Corroded product	black, medium, discontinuous, compact, hard
CP4	Corroded product	dark brown, medium, continuous, compact, soft
CP5	Corroded product	red, thin, discontinuous, non-compact, powdery, soft
CP6	Corroded product	light beige, thin, continuous, compact, very soft
M1	Metal	yellowish grey, metallic, hard
M2	Metal	grey-white, metallic, soft

Fig. 3: Stratigraphic representation of the corrosion structure of the vase by macroscopic and binocular observation with indication of the corrosion structure used to build the MiCorr stratigraphy of Fig. 4 (red rectangle),

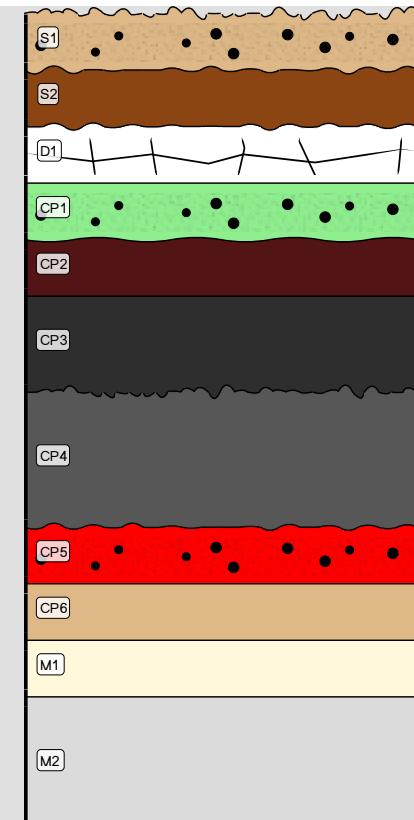
Fig. 4: Stratigraphic representation of the corrosion structure of the vase observed macroscopically under binocular microscope using the MiCorr application with reference to Fig. 3. The characteristics of the strata are only accessible by clicking on the drawing that redirects you to the search tool by stratigraphy representation, credit HE-Arc CR, S.Béguelin.

Compared with Figure 4, the amount of information is just limited to an area where there is only one blister. Observation of the cross-section did not reveal all the corrosion layers visible on the entire object when it was probed under binoculars. In fact, only two layers of corrosion are visible (CP1 and CP2) (Fig. 19). They correspond to two different corrosion layers of the Bi MiCorr stratigraphy (CP2 and CP4, Fig. 4). CM1 (Fig.19) could correspond to CP6 and M1 on Fig. 4. M2 on Fig. 4 corresponds to M1 on Fig. 19.

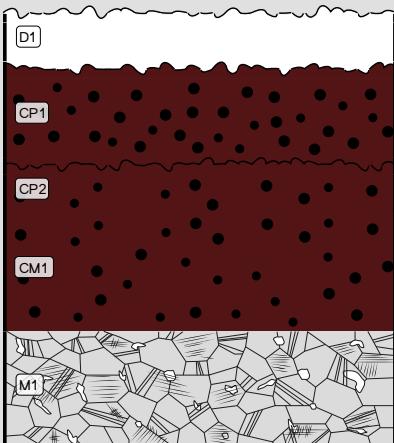
Fig. 19: Stratigraphic representation of the sample of the vase observed in cross-section under dark field using the MiCorr application. The characteristics of the strata are only accessible by clicking on the drawing that redirects you to the search tool by stratigraphy representation. This representation was build according to Fig.15, credit HE-Arc CR, S.Béguelin.

The lack of information when examining the cross-section is due to the fact that the colours of the layers are very close to each other. The sample is fairly representative of the object, showing mainly a layer of corrosion rich in Ag, Cl and Br on a metal that is subject to intergranular corrosion. The sample's location was chosen because it's a discrete area and it allowed us to analyse the metal at its core.

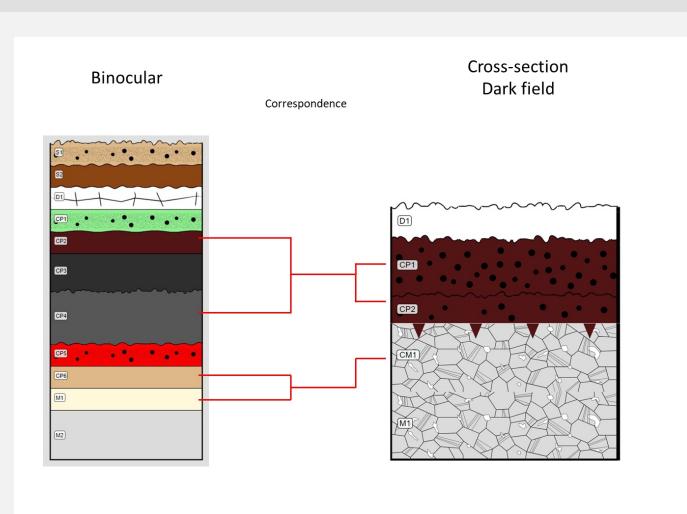
Fig. 20: Stratigraphic representation side by side of binocular view and cross-section (dark field),
