ANTHROPOMORPHIC VASE – AG ALLOY – ROMAN TIMES

Artefact name Anthropomorphic vase

Authors (HE-Arc CR, Neuchâtel, Neuchâtel, Switzerland). (Christian Degrigny, None) & Solène. Béguelin (HE-Arc CR, Neuchâtel, Neuchâtel, Switzerland) & Valentin. Boissonnas (HE-Arc CR, Neuchâtel, Neuchâtel, Switzerland)

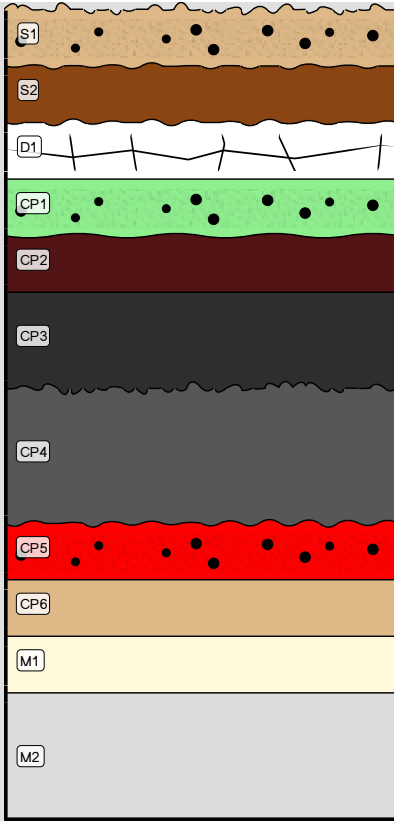
Fig. 4: Stratigraphic representation of the corrosion structure of the vase observed macroscopically under binocular microscope using the MiCorr application with reference to Fig. 3. The characteristics of the strata are only accessible by clicking on the drawing that redirects you to the search tool by stratigraphy representation, credit HE-Arc CR, S.Béguelin.
