SITULA EMT09-554.665 - TIN BRONZE - IRON AGE - SWITZERLAND

Artefact name	Situla EMT09-554.665
Authors	Christian. Degriigny (HE-Arc CR, Neuchâtel, Neuchâtel, Switzerland) & Marie-Jeanne. Scholl (HE-Arc CR, Neuchâtel, Neuchâtel, Switzerland) & Valentin. Boissonnas (HE-Arc CR, Neuchâtel, Neuchâtel, Switzerland)
Url	/artefacts/1506/

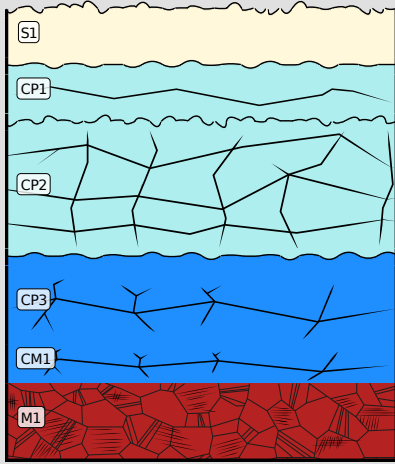
Fig. 14: Stratigraphic representation of the sample taken from the detached fragment of the situla in cross-section (dark field) using the MiCorr application. The characteristics

There are 2 stratigraphies (Fig. 14 corresponding to the interior face of the situla and Fig. 15 to its exterior face). The strata are similar in composition but their coding is different: CP1 to CP3 in Fig. 14 correspond to CP3 to CP5 in Fig. 15. Since the stratigraphy of Fig. 15 is more complete, the composition of each of its strata is given below.

of the strata are only accessible by clicking on the drawing that redirects you to the search tool by stratigraphy representation. This representation shows the interior face and can be compared to Fig. 8 (bottom red rectangle), Credit HE-Arc CR, M-J.Scholl.

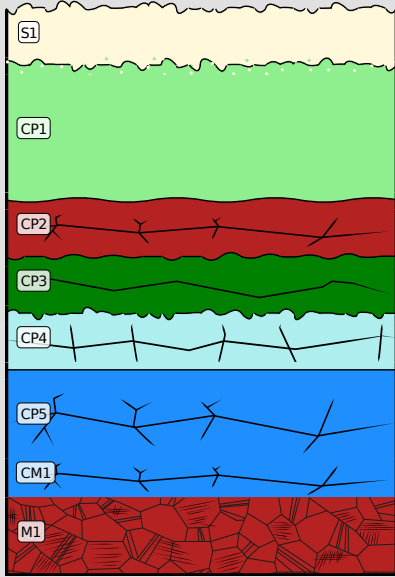
The limit of the original surface is well defined (interface of CP1 and CP2) but due to the fragility of the inner corrosion layers it was difficult to uncover.

Fig. 15: Stratigraphic representation of the sample taken from the detached fragment of the situla in cross-section (dark field) using the MiCorr application. The characteristics of the strata are only accessible by clicking on the drawing that redirects you to the search tool by stratigraphy representation. This representation shows the exterior face and can be compared to Fig. 8 (top red rectangle), Credit HE-Arc CR, M-J.Scholl.
