FUNERAL MASK IVC 11595 – CU/AG, WITH SURFACE ENRICHMENT (AG) – UNKNOWN – PERU

Artefact name Funeral mask Ivc 11595

Authors Christian. Degrygn (HE-Arc CR, Neuchâtel, Neuchâtel, Switzerland) & Naima. Gutknecht (HE-Arc CR, Neuchâtel, Neuchâtel, Switzerland) & Valentin. Boissonnas (HE-Arc CR, Neuchâtel, Neuchâtel, Switzerland)

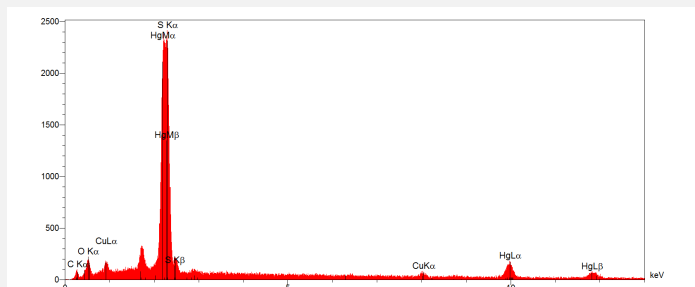
Fig. 12: EDS analysis of the red surface pigment from a surface sample. Method of analysis: SEM-EDS, Lab of Electronic Microscopy and Microanalysis, IMA (Néode), HEI Arc,
