## FUNERAL MASK IVC 11595 – CU/AG, WITH SURFACE ENRICHMENT (AG) – UNKNOWN – PERU

| <b>Artefact name</b> | Funeral mask Ivc 11595 |
| <b>Authors</b> | Christian. Degrygn (HE-Arc CR, Neuchâtel, Neuchâtel, Switzerland) & Naima. Gutknecht (HE-Arc CR, Neuchâtel, Neuchâtel, Switzerland) & Valentin. Boissonnas (HE-Arc CR, Neuchâtel, Neuchâtel, Switzerland) |

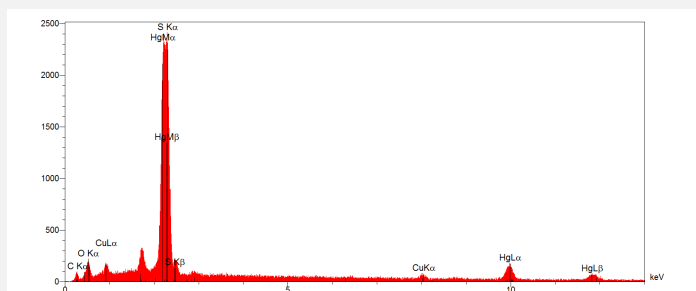
Fig. 12: EDS analysis of the red surface pigment from a surface sample. Method of analysis: SEM-EDS, Lab of Electronic Microscopy and Microanalysis, IMA (Néode), HEI Arc,
