FUNERAL MASK IVC 11595 – CU/AG, WITH SURFACE ENRICHMENT (AG) – UNKNOWN – PERU

Artefact name	Funeral mask Ivc 11595
Authors	Christian. Degrygn (HE-Arc CR, Neuchâtel, Neuchâtel, Switzerland) & Naima. Gutknecht (HE-Arc CR, Neuchâtel, Neuchâtel, Switzerland) & Valentin. Boissonnas (HE-Arc CR, Neuchâtel, Neuchâtel, Switzerland)
Url	/artefacts/1556/

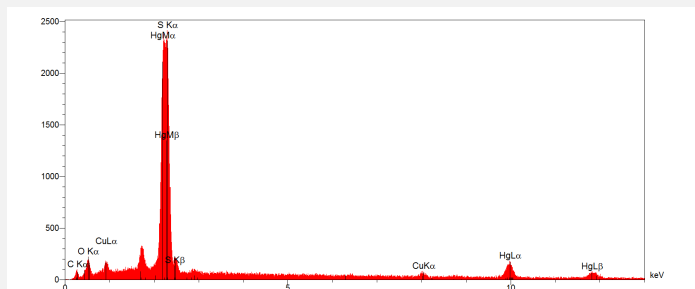
Fig. 12: EDS analysis of the red surface pigment from a surface sample. Method of analysis: SEM-EDS, Lab of Electronic Microscopy and Microanalysis, IMA (Néode), HEI Arc,

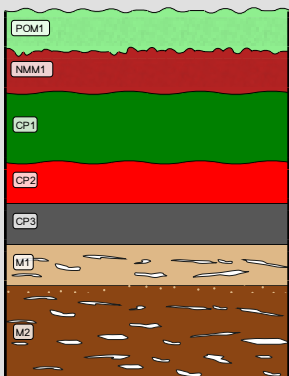
The silver enriched surface is entirely covered with copper corrosion products. The outer green layer (CP1) is a copper carbonate (Fig. 11, Table 1), while the red layers (CP2 in Fig. 15 ; CP4 and CP5 in Fig. 16) are consisting of a copper oxide, most likely cuprite (Fig. 9). Below the cuprite and above the silver enriched surface on the front face a thin black layer is present (appears grey under polarized light). SEM-EDS analysis shows that in that stratum the mercury of the pigment (Fig. 14) has been transformed into a mercury-silver compound (Figs. 7 and 10) which according to Raman spectrometry (Fig. 14) is not cinnabar anymore. In areas this silver- and mercury-rich surface has been pulled off by raising the corrosion layers, leaving structural voids that were subsequently filled by secondary corrosion products, most likely copper carbonates (Figs. 6 and 7).

Fig. 15: Stratigraphic representation of the cross-section (dark field) from Figs. 3a or 4 (front of the object) using the MiCorr application. The characteristics of the strata are only accessible by clicking on the drawing that redirects you to the search tool by stratigraphy representation, Credit HE-Arc CR, N. Gutknecht.

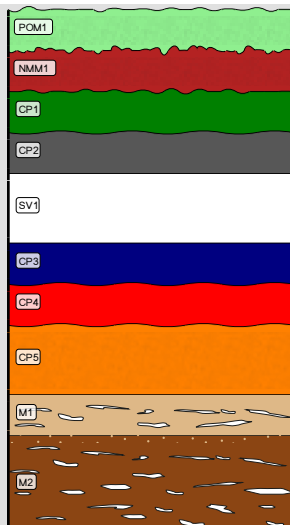
Fig. 16: Stratigraphic representation of the cross-section (dark field) from Figs. 3b and 4 (back of the object) using the MiCorr application. CP2 is CP3 while CP3 is CP4 and CP4 is CP2 in Fig. 3b. The characteristics of the strata are only accessible by clicking on the drawing that redirects you to the search tool by stratigraphy representation, Credit HE-Arc CR, N. Gutknecht.
