# FUNERAL MASK IVC 11595 – CU/AG, WITH SURFACE ENRICHMENT (AG) – UNKNOWN – PERU

**Artefact name** Funeral mask Ivc 11595

**Authors** Christian. Degrygn (HE-Arc CR, Neuchâtel, Neuchâtel, Switzerland) & Naima. Gutknecht (HE-Arc CR, Neuchâtel, Neuchâtel, Switzerland) & Valentin. Boissonnas (HE-Arc CR, Neuchâtel, Neuchâtel, Switzerland)

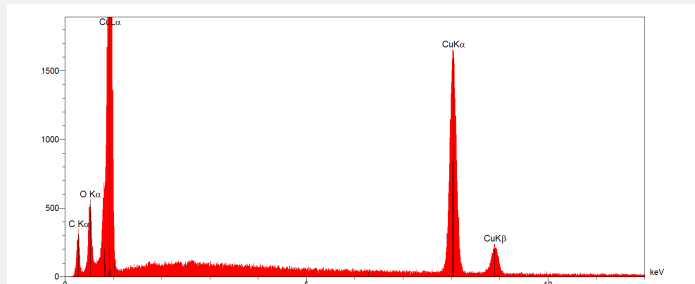
Fig. 12: EDS analysis of the red surface pigment from a surface sample. Method of analysis: SEM-EDS, Lab of Electronic Microscopy and Microanalysis, IMA (Néode), HEI Arc,

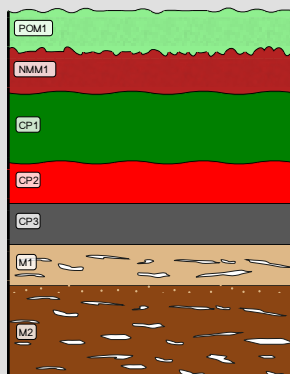
The silver enriched surface is entirely covered with copper corrosion products. The outer green layer (CP1) is a copper carbonate (Fig. 11, Table 1), while the red layers (CP2 in Fig. 15 ; CP4 and CP5 in Fig. 16) are consisting of a copper oxide, most likely cuprite (Fig. 9). Below the cuprite and above the silver enriched surface on the front face a thin black layer is present (appears grey under polarized light). SEM-EDS analysis shows that in that stratum the mercury of the pigment (Fig. 14) has been transformed into a mercury-silver compound (Figs. 7 and 10) which according to Raman spectrometry (Fig. 14) is not cinnabar anymore. In areas this silver- and mercury-rich surface has been pulled off by raising the corrosion layers, leaving structural voids that were subsequently filled by secondary corrosion products, most likely copper carbonates (Figs. 6 and 7).

Fig. 15: Stratigraphic representation of the cross-section (dark field) from Figs. 3a or 4 (front of the object) using the MiCorr application. The characteristics of the strata are only accessible by clicking on the drawing that redirects you to the search tool by stratigraphy representation, Credit HE-Arc CR, N. Gutknecht.

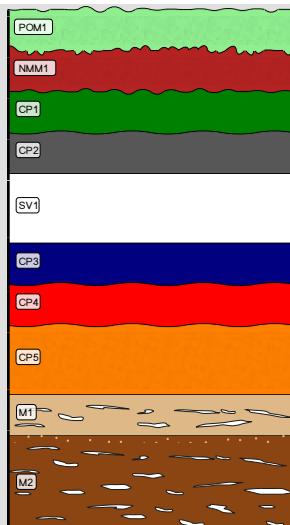
Fig. 16: Stratigraphic representation of the cross-section (dark field) from Figs. 3b and 4 (back of the object) using the MiCorr application. CP2 is CP3 while CP3 is CP4 and CP4 is CP2 in Fig. 3b. The characteristics of the strata are only accessible by clicking on the drawing that redirects you to the search tool by stratigraphy representation, Credit HE-Arc CR, N. Gutknecht.
