## FUNERAL MASK IVC 11595 – CU/AG, WITH SURFACE ENRICHMENT (AG) – UNKNOWN – PERU

<b>Artefact name</b>	Funeral mask Ivc 11595
<b>Authors</b>	Christian. Degrygn (HE-Arc CR, Neuchâtel, Neuchâtel, Switzerland) & Naima. Gutknecht (HE-Arc CR, Neuchâtel, Neuchâtel, Switzerland) & Valentin. Boissonnas (HE-Arc CR, Neuchâtel, Neuchâtel, Switzerland)
<b>Url</b>	/artefacts/1557/

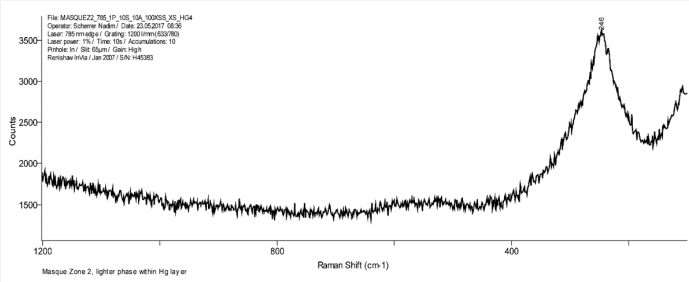
Fig. 14: Raman analysis of the mercury compounds from the cross section. Method of analysis: Raman spectroscopy, HKB,

The artefact is a repeatedly hammered, annealed and pickled Cu-Ag tumbaga. The cuprite and hydroxycarbonate layers and the presence of chlorides are typical for the corrosion of tumbaga alloys in an archaeological context. Cinnabar has been identified as pigment applied to the surface before burial. Over the centuries, it was partially incorporated into the growing copper corrosion layers.
