# LEAD CAMES OF A STAINED GLASS WINDOW 52583 – PB SB ALLOY – UNKNOWN – SWITZERLAND

**Artefact name** Lead comes of a stained glass window 52583

**Authors** Alice Gerber. (Haute École Arc Neuchâtel, Neuchâtel, Neuchâtel, Switzerland)

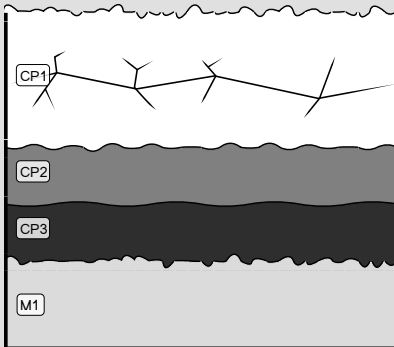
In 2009 two stained glass panels were placed in a showcase for a permanent exhibition, the lead came were then in a good conservation condition. In 2018, the lead showed voluminous efflorescence of white, powdery corrosion products.

Fig. 4: Stratigraphic representation of the corrosion structure of the lead came observed macroscopically under binocular microscope using the MiCorr application. The characteristics of the strata are only accessible by clicking on the drawing that redirects you to the search tool by stratigraphy representation, Credit HE-Arc CR, A.Gerber.

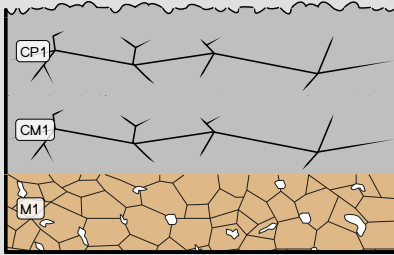
Corrosion develops specifically on comes made of a lead-antimony alloy, where antimony inclusions constitute the cathode (0.150 V/SHE) versus lead (-0.125 V/SHE) which corrodes as an anode in presence of lead acetate (the electrolyte). Fig. 8 shows that corrosion does not attack the antimony nodules in the alloy, it progresses by mineralizing the lead around these nodules.

<b>Corrosion form</b>	Uniform - transgranular
<b>Corrosion type</b>	Active corrosion of lead

Fig. 10: Stratigraphic representation of the lead came in cross-section (dark field) using the MiCorr application with reference to Fig. 8. The characteristics of the strata are only accessible by clicking on the drawing that redirects you to the search tool by stratigraphy representation, Credit HE-Arc CR, A.Gerber.
