ANTHROPOMORPHIC VASE – AG ALLOY – ROMAN TIMES

Artefact name Anthropomorphic vase

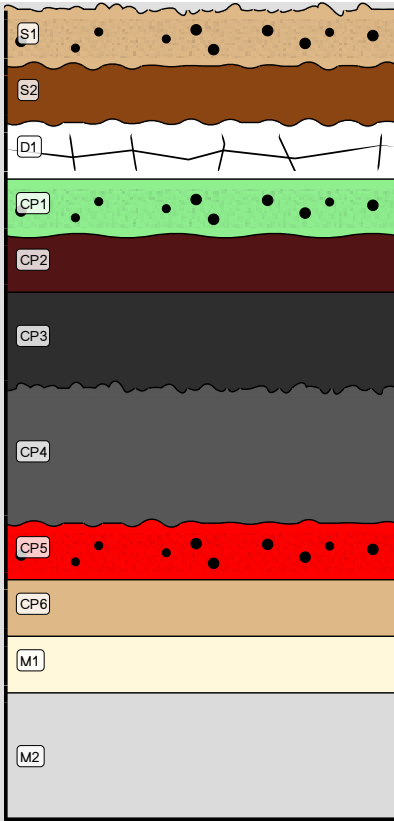
Fig. 4: Stratigraphic representation of the corrosion structure of the vase observed macroscopically under binocular microscope using the MiCorr application with reference to Fig. 3. The characteristics of the strata are only accessible by clicking on the drawing that redirects you to the search tool by stratigraphy representation, credit HE-Arc CR, S.Béguelin.
