ANTHROPOMORPHIC VASE – AG ALLOY – ROMAN TIMES

Artefact name Anthropomorphic vase

Authors (HE-Arc CR, Neuchâtel, Neuchâtel, Switzerland). (Christian Degriigny, None) & Solène. Béguelin (HE-Arc CR, Neuchâtel, Neuchâtel, Switzerland) & Valentin. Boissonnas (HE-Arc CR, Neuchâtel, Neuchâtel, Switzerland)

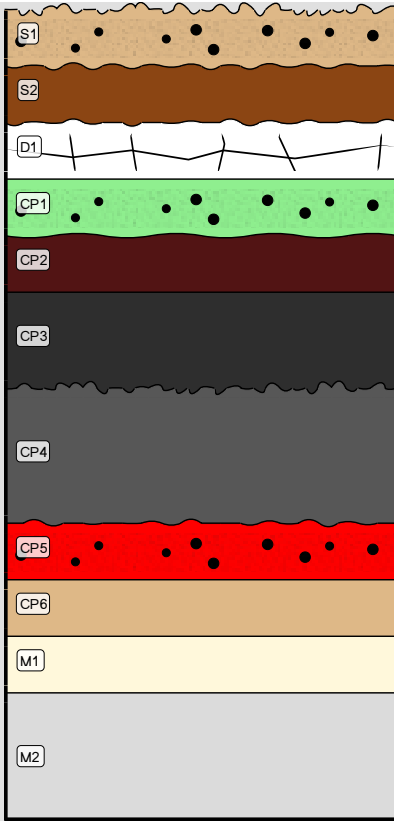
Fig. 4: Stratigraphic representation of the corrosion structure of the vase observed macroscopically under binocular microscope using the MiCorr application with reference to Fig. 3. The characteristics of the strata are only accessible by clicking on the drawing that redirects you to the search tool by stratigraphy representation, credit HE-Arc CR, S.Béguelin.

Compared with Figure 4, the amount of information is just limited to an area where there is only one blister. Observation of the cross-section did not reveal all the corrosion layers visible on the entire object when it was probed under binoculars. In fact, only two layers of corrosion are visible (CP1 and CP2) (Fig. 19). They correspond to two different corrosion layers of the Bi MiCorr stratigraphy (CP2 and CP4, Fig. 4). CM1 (Fig.19) could correspond to CP6 and M1 on Fig. 4. M2 on Fig. 4 corresponds to M1 on Fig. 19.

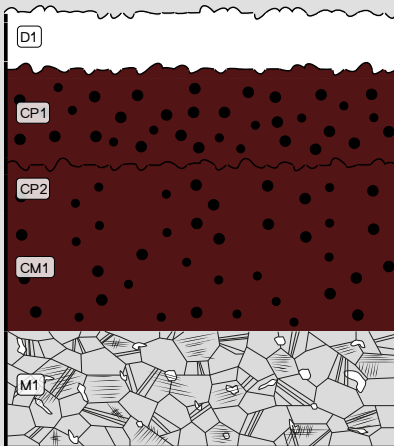
Fig. 19: Stratigraphic representation of the sample of the vase observed in cross-section under dark field using the MiCorr application. The characteristics of the strata are only accessible by clicking on the drawing that redirects you to the search tool by stratigraphy representation. This representation was built according to Fig.15, credit HE-Arc CR, S.Béguelin.
