## ANTHROPOMORPHIC VASE – AG ALLOY – ROMAN TIMES

**Artefact name** Anthropomorphic vase

**Authors** (HE-Arc CR, Neuchâtel, Neuchâtel, Switzerland). (Christian Degrigny, None) & Solène. Béguelin (HE-Arc CR, Neuchâtel, Neuchâtel, Switzerland) & Valentin. Boissonnas (HE-Arc CR, Neuchâtel, Neuchâtel, Switzerland)

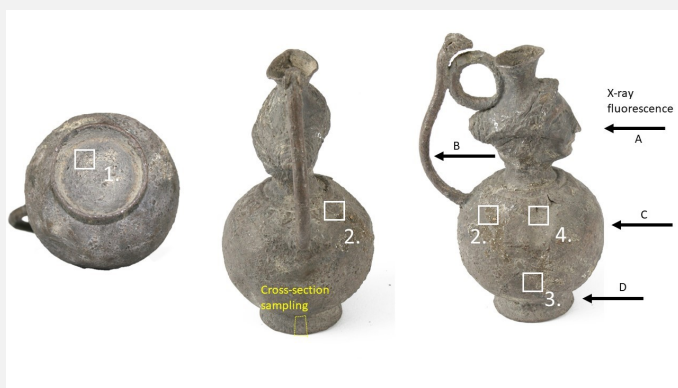
Fig. 2: Locations of the four points analysed with X-ray fluorescence (black arrows A-D), the four samples (numbers 1-4) and the cross-section (yellow) analysed with SEM-EDS,

The XRF analysis of the vase was carried out before sampling on four areas (Fig. 2). During the analysis, the layers of soil, corrosion and metal are analysed at the same time. The metal is probably a silver alloy with a small amount of Cu (and possibly Bi?). Some of the other elements detected are part of the burial environment (Al, Si, Fe, Cr) and corrosion products (Br, Cl). Titanium is probably an artefact.

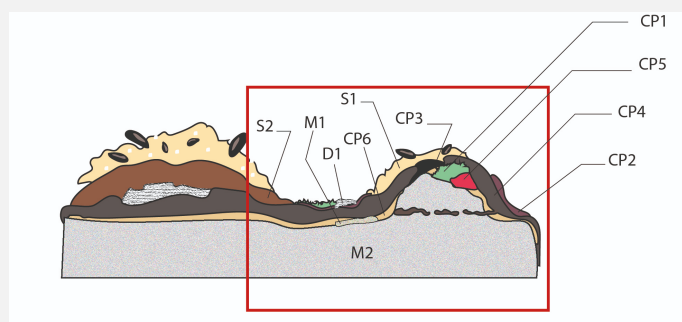
Strata	Type of Stratum	Principal Characteristics
S1	Soil (with mica / feldspath)	light beige, medium, non-compact, powdery and containing black-brown scattered aggregates
S2	Soil	brown, medium, compact, very soft
D1	Deposit	white, thin, compact, hard, brittle
CP1	Corroded product	light green, thin, discontinuous, non-compact, powdery
CP2	Corroded product	pinkish brown, thin, discontinuous, compact, soft
CP3	Corroded product	black, medium, discontinuous, compact, hard
CP4	Corroded product	dark brown, medium, continuous, compact, soft
CP5	Corroded product	red, thin, discontinuous, non-compact, powdery, soft
CP6	Corroded product	light beige, thin, continuous, compact, very soft
M1	Metal	yellowish grey, metallic, hard
M2	Metal	grey-white, metallic, soft

Fig. 3: Stratigraphic representation of the corrosion structure of the vase by macroscopic and binocular observation with indication of the corrosion structure used to build the MiCorr stratigraphy of Fig. 4 (red rectangle),

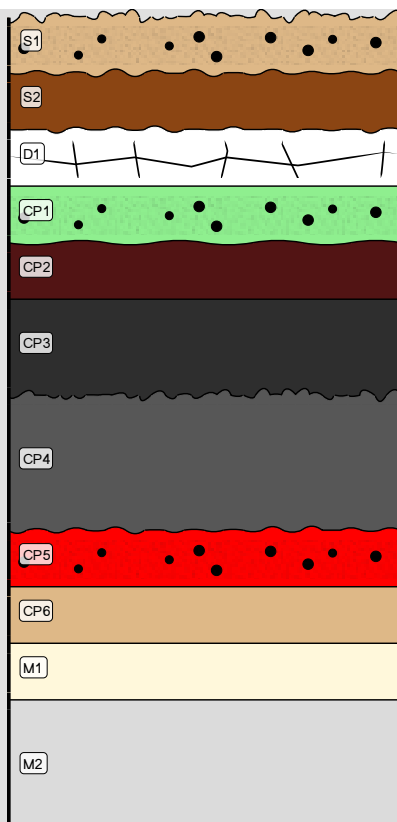
Fig. 4: Stratigraphic representation of the corrosion structure of the vase observed macroscopically under binocular microscope using the MiCorr application with reference to Fig. 3. The characteristics of the strata are only accessible by clicking on the drawing that redirects you to the search tool by stratigraphy representation, credit HE-Arc CR, S.Béguelin.

Compared with Figure 4, the amount of information is just limited to an area where there is only one blister. Observation of the cross-section did not reveal all the corrosion layers visible on the entire object when it was probed under binoculars. In fact, only two layers of corrosion are visible (CP1 and CP2) (Fig. 19). They correspond to two different corrosion layers of the Bi MiCorr stratigraphy (CP2 and CP4, Fig. 4). CM1 (Fig.19) could correspond to CP6 and M1 on Fig. 4. M2 on Fig. 4 corresponds to M1 on Fig. 19.

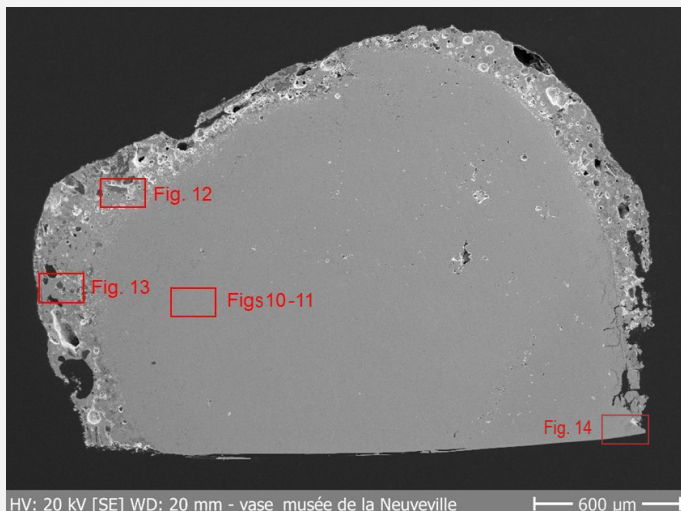
Fig. 9: SEM picture (SE mode) of the cross-section of the vase showing the location of Figs.10 to 14, unetched,

The cross-section embedded corresponds to a transversal cut made on the foot of the container (Fig. 2). A metallic core is present below the corrosion layers (Fig. 9).

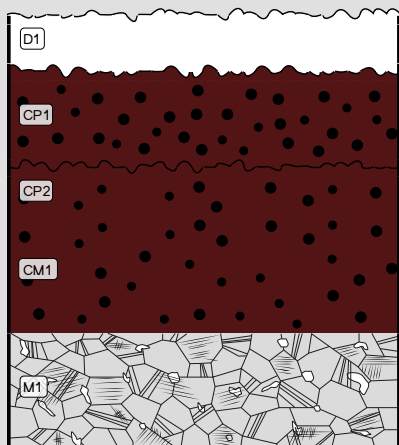
Fig. 19: Stratigraphic representation of the sample of the vase observed in cross-section under dark field using the MiCorr application. The characteristics of the strata are only accessible by clicking on the drawing that redirects you to the search tool by stratigraphy representation. This representation was build according to Fig.15, credit HE-Arc CR, S.Béguelin.

The lack of information when examining the cross-section is due to the fact that the colours of the layers are very close to each other. The sample is fairly representative of the object, showing mainly a layer of corrosion rich in Ag, Cl and Br on a metal that is subject to intergranular corrosion. The sample's location was chosen because it's a discrete area and it allowed us to analyse the metal at its core.

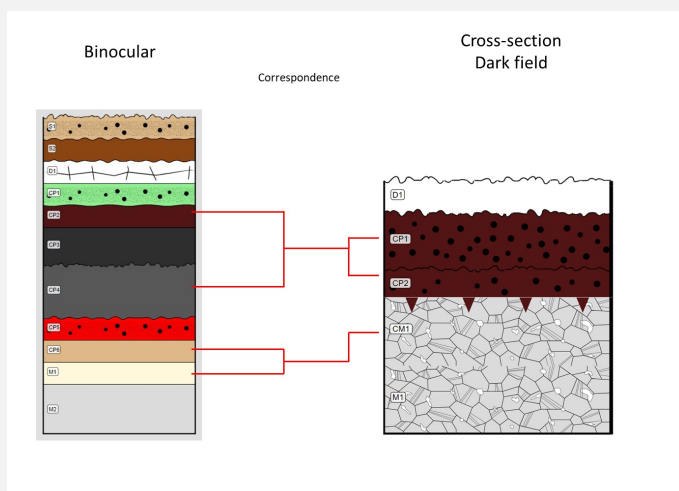
Fig. 20: Stratigraphic representation side by side of binocular view and cross-section (dark field),
