## ANTHROPOMORPHIC VASE – AG ALLOY – ROMAN TIMES

**Artefact name** Anthropomorphic vase

**Authors** (HE-Arc CR, Neuchâtel, Neuchâtel, Switzerland). (Christian Degriigny, None) & Solène. Béguelin (HE-Arc CR, Neuchâtel, Neuchâtel, Switzerland) & Valentin. Boissonnas (HE-Arc CR, Neuchâtel, Neuchâtel, Switzerland)

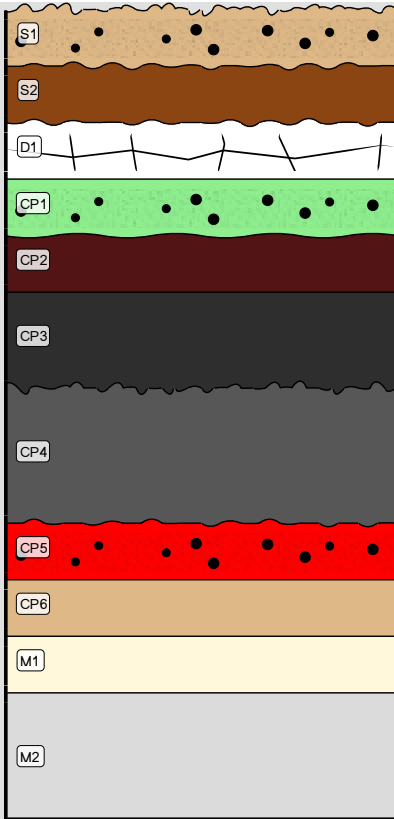
Fig. 4: Stratigraphic representation of the corrosion structure of the vase observed macroscopically under binocular microscope using the MiCorr application with reference to Fig. 3. The characteristics of the strata are only accessible by clicking on the drawing that redirects you to the search tool by stratigraphy representation, credit HE-Arc CR, S.Béguelin.
