AIRCRAFT REAR FASTENING PLATE VHS-497 – AL ALLOY – MODERN TIMES – SWITZERLAND

Artefact name	Aircraft rear fastening plate VHS-497
Authors	Marianne. Senn (Empa, Dübendorf, Zurich, Switzerland) & Christian. Degriigny (HE-Arc CR, Neuchâtel, Neuchâtel, Switzerland)
Url	/artefacts/1571/

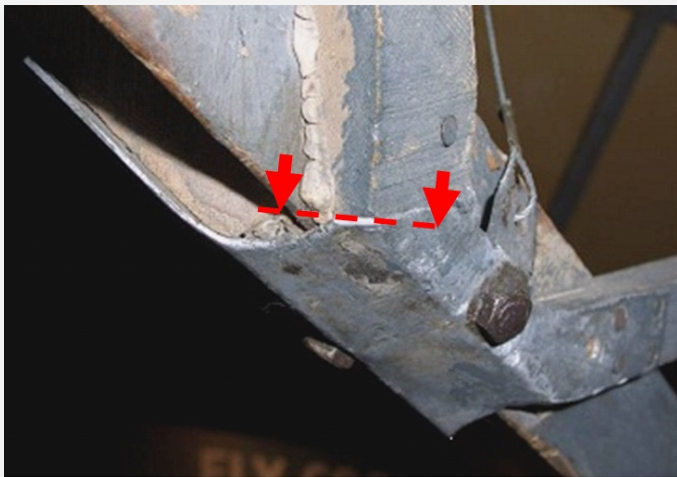
Fig. 2: Location of sampling area,

Description of sample	Sample cut from the corner of the fastening plate (Fig. 2). Dimensions: L = 4mm ; W = 1.2mm.
Alloy	Al Alloy
Technology	Hot rolled and annealed
Lab number of sample	DUF-12
Sample location	HE-Arc CR, Neuchâtel, Neuchâtel
Responsible institution	Swiss Museum of Transport, Luzern, Lucerne
Date and aim of sampling	September 2007, metallography and alloy composition
