# AIRCRAFT FRONT FASTENING PLATE VHS-497 (2) – AL CU SN ZN SI ALLOY – MODERN TIMES – SWITZERLAND

**Artefact name** Aircraft front fastening plate VHS-497 (2)

**Authors** Marianne. Senn (Empa, Dübendorf, Zurich, Switzerland) & Christian. Degryny (HE-Arc CR, Neuchâtel, Neuchâtel, Switzerland)

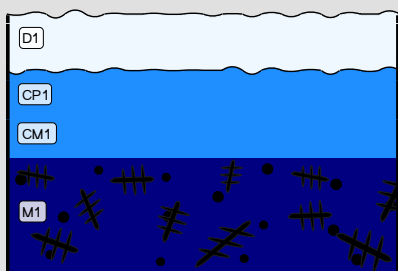
No corrosion layer can be seen on the metal surface (Figs. 3 and 6). Under polarized light small white and brown particles are visible on the broken edge (D1, Fig. 7). Their analysis reveals the presence of silica particles surrounded by dirt (Table 2 and Fig. 8). The metal surface is covered by a thin oxygen bearing skin (CP1, Fig. 8).

Fig. 9: Stratigraphic representation of the sample taken from the front fastening plate in cross-section (dark field) using the MiCorr application. The characteristics of the strata are only accessible by clicking on the drawing that redirects you to the search tool by stratigraphy representation. This representation can be compared to Fig. 7, Credit HE-Arc CR.

This front fastening plate of Dufaux IV plane is made in cast Al-Cu-Sn-Zn-Si, an alloy rather common at the beginning of the 20th century. No corrosion layer has been found on the metal surface except adherent silica-rich particles and the thin oxidised skin typical of Al alloys. The presence of these materials can be explained by the regular maintenance of the metal, probably using silicon carbide abrasive paper.
