LEAD CAMES OF A STAINED GLASS WINDOW 52583 – PB SB ALLOY – UNKNOWN – SWITZERLAND

Artefact name Lead comes of a stained glass window 52583

Authors Alice Gerber. (Haute École Arc Neuchâtel, Neuchâtel, Neuchâtel, Switzerland)

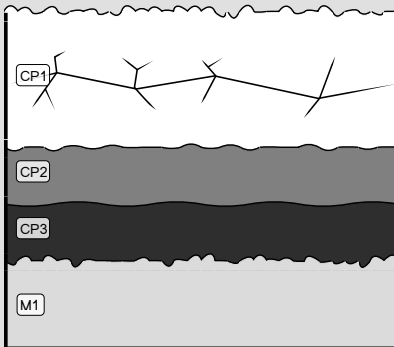
Fig. 4: Stratigraphic representation of the corrosion structure of the lead came observed macroscopically under binocular microscope using the MiCorr application. The characteristics of the strata are only accessible by clicking on the drawing that redirects you to the search tool by stratigraphy representation, Credit HE-Arc CR, A.Gerber.

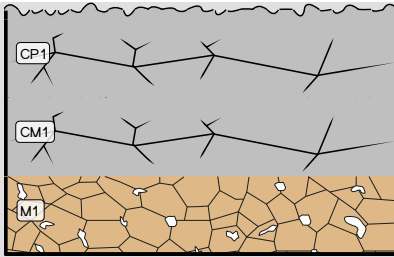
Fig. 10: Stratigraphic representation of the lead came in cross-section (dark field) using the MiCorr application with reference to Fig. 8. The characteristics of the strata are only accessible by clicking on the drawing that redirects you to the search tool by stratigraphy representation, Credit HE-Arc CR, A.Gerber.
