FUNERAL MASK IVC 11595 – CU/AG, WITH SURFACE ENRICHMENT (AG) – UNKNOWN – PERU

Artefact name	Funeral mask Ivc 11595
Authors	Christian. Degrygn (HE-Arc CR, Neuchâtel, Neuchâtel, Switzerland) & Naima. Gutknecht (HE-Arc CR, Neuchâtel, Neuchâtel, Switzerland) & Valentin. Boissonnas (HE-Arc CR, Neuchâtel, Neuchâtel, Switzerland)
Url	/artefacts/1582/

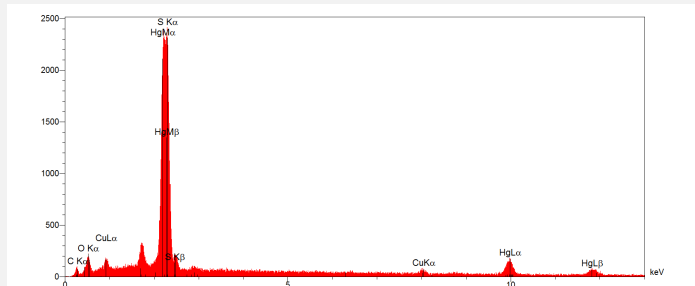
Fig. 12: EDS analysis of the red surface pigment from a surface sample. Method of analysis: SEM-EDS, Lab of Electronic Microscopy and Microanalysis, IMA (Néode), HEI Arc,
