FUNERAL MASK IVC 11595 – CU/AG, WITH SURFACE ENRICHMENT (AG) – UNKNOWN – PERU

Artefact name	Funeral mask Ivc 11595
Authors	Christian. Degrygn (HE-Arc CR, Neuchâtel, Neuchâtel, Switzerland) & Naima. Gutknecht (HE-Arc CR, Neuchâtel, Neuchâtel, Switzerland) & Valentin. Boissonnas (HE-Arc CR, Neuchâtel, Neuchâtel, Switzerland)
Url	/artefacts/1582/

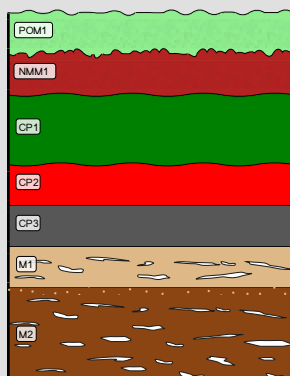
The silver enriched surface is entirely covered with copper corrosion products. The outer green layer (CP1) is a copper carbonate (Fig. 11, Table 1), while the red layers (CP2 in Fig. 15 ; CP4 and CP5 in Fig. 16) are consisting of a copper oxide, most likely cuprite (Fig. 9). Below the cuprite and above the silver enriched surface on the front face a thin black layer is present (appears grey under polarized light). SEM-EDS analysis shows that in that stratum the mercury of the pigment (Fig. 14) has been transformed into a mercury-silver compound (Figs. 7 and 10) which according to Raman spectrometry (Fig. 14) is not cinnabar anymore. In areas this silver- and mercury-rich surface has been pulled off by raising the corrosion layers, leaving structural voids that were subsequently filled by secondary corrosion products, most likely copper carbonates (Figs. 6 and 7).

Fig. 15: Stratigraphic representation of the cross-section (dark field) from Figs. 3a or 4 (front of the object) using the MiCorr application. The characteristics of the strata are only accessible by clicking on the drawing that redirects you to the search tool by stratigraphy representation, Credit HE-Arc CR, N. Gutknecht.

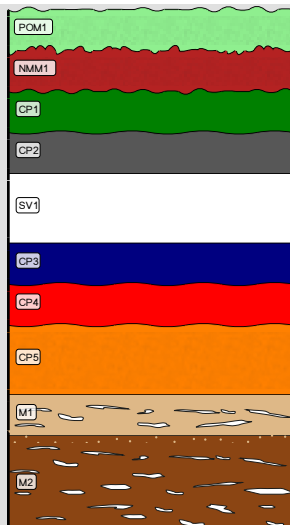
Fig. 16: Stratigraphic representation of the cross-section (dark field) from Figs. 3b and 4 (back of the object) using the MiCorr application. CP2 is CP3 while CP3 is CP4 and CP4 is CP2 in Fig. 3b. The characteristics of the strata are only accessible by clicking on the drawing that redirects you to the search tool by stratigraphy representation, Credit HE-Arc CR, N. Gutknecht.
