FUNERAL MASK IVC 11595 – CU/AG, WITH SURFACE ENRICHMENT (AG) – UNKNOWN – PERU

Artefact name	Funeral mask Ivc 11595
Authors	Christian. Degrygn (HE-Arc CR, Neuchâtel, Neuchâtel, Switzerland) & Naima. Gutknecht (HE-Arc CR, Neuchâtel, Neuchâtel, Switzerland) & Valentin. Boissonnas (HE-Arc CR, Neuchâtel, Neuchâtel, Switzerland)
Url	/artefacts/1582/

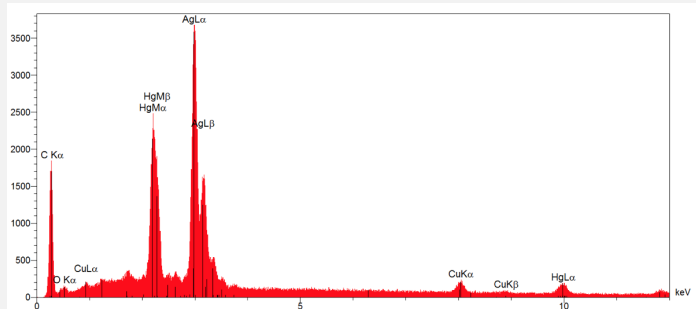
Figs. 10: EDS analysis of the layer that appears light grey under polarized light, situated below the red layer (Fig. 4). Method of analysis: SEM-EDS, Lab of Electronic Microscopy and Microanalysis, IMA (Néode), HEI Arc,
