MILITARY ID TAG 5668-MXX-1008-1 - ZN PB ALLOY - MODERN TIMES - FRANCE

Artefact name	Military ID tag 5668-MXX-1008-1
Authors	Christian. Degryny (HE-Arc CR, Neuchâtel, Neuchâtel, Switzerland) & Marie-Jeanne. Scholl (HE-Arc CR, Neuchâtel, Neuchâtel, Switzerland) & Valentin. Boissonnas (HE-Arc CR, Neuchâtel, Neuchâtel, Switzerland)
Url	/artefacts/213/

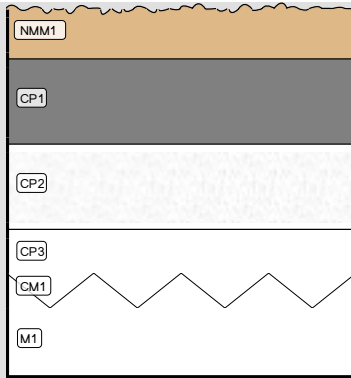
Fig. 5: Stratigraphic representation of the object in cross-section using the MiCorr application. This representation can be compared to Fig. 10.

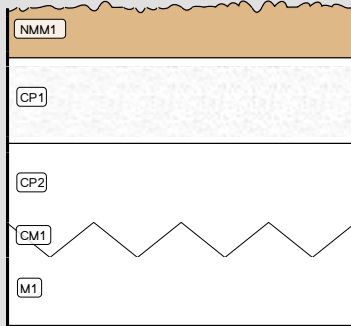
Fig. 6: Stratigraphic representation of the object in cross-section using the MiCorr application. This representation is different from Fig. 10 due to the inversion of CP1 and CP2. Furthermore, CP3 is not represented.
