MILITARY ID TAG 5668-MXX-1008-1 - ZN PB ALLOY - MODERN TIMES - FRANCE

Artefact name Military ID tag 5668-MXX-1008-1

Authors Christian. Degrygn (HE-Arc CR, Neuchâtel, Neuchâtel, Switzerland) & Marie-Jeanne. Scholl (HE-Arc CR, Neuchâtel, Neuchâtel, Switzerland) & Valentin. Boissonnas (HE-Arc CR, Neuchâtel, Neuchâtel, Switzerland)

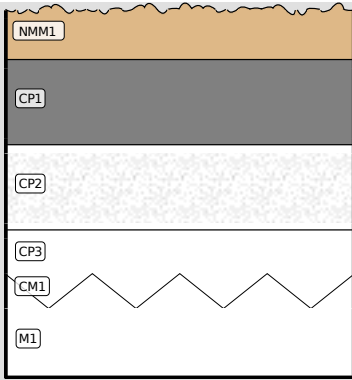
Fig. 5: Stratigraphic representation of the object in cross-section using the MiCorr application. This representation can be compared to Fig. 10.

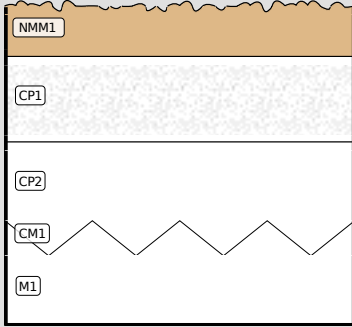
Fig. 6: Stratigraphic representation of the object in cross-section using the MiCorr application. This representation is different from Fig. 10 due to the inversion of CP1 and CP2. Furthermore, CP3 is not represented.
