MILITARY ID TAG 5668-MXX-1008-1 - ZN PB ALLOY - MODERN TIMES - FRANCE

Artefact name Military ID tag 5668-MXX-1008-1

Authors Christian. Degryny (HE-Arc CR, Neuchâtel, Neuchâtel, Switzerland) & Marie-Jeanne. Scholl (HE-Arc CR, Neuchâtel, Neuchâtel, Switzerland) & Valentin. Boissonnas (HE-Arc CR, Neuchâtel, Neuchâtel, Switzerland)

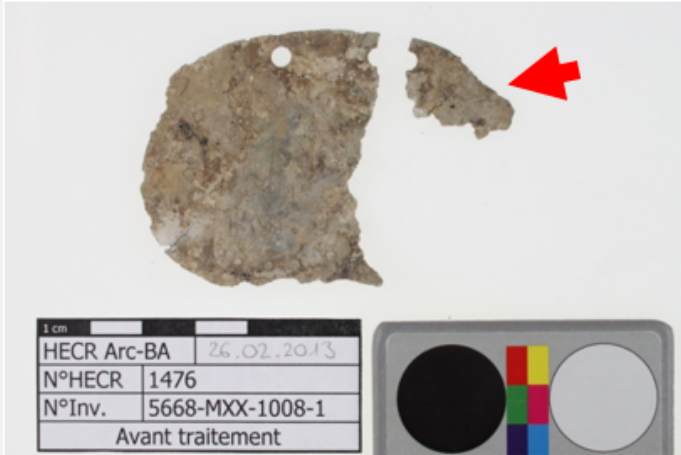
Fig. 2: Location of sample,

Description of sample	This sample was cut out of fragment b in Fig. 1. The cross-section shows the entire thickness of the plate (L = 8 mm, W= 1 mm). The corrosion goes through the whole metal thickness but a metallic core remains (Fig. 4).
Alloy	Zn Pb Alloy
Technology	Cold worked (laminated)
Lab number of sample	-
Sample location	HE-Arc CR, Neuchâtel, Neuchâtel
Responsible institution	Pôle d'Archéologie Interdépartemental Rhénan, Sélestat, Alsace
Date and aim of sampling	2013, metallography and chemical analyses

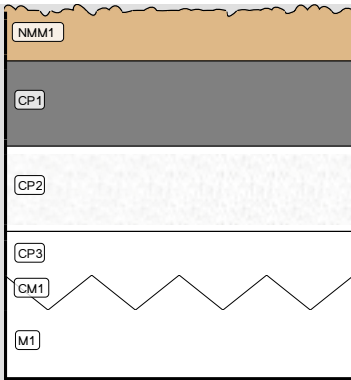
The corrosion spreads on the entire thickness of the plate and different forms of corrosion within the same plate may occur (multiform corrosion). Sometimes the metal core still remains, sometimes not.

The corrosion structure is multi-layered: several corrosion products overlap. However they are not all continuous layers, since some of them are isolated. Most of the corrosion products layers show structural voids (up to 100 µm thick) and some cracks inside. Three layers can be distinguished (Fig. 8) which have the same elements but in different proportions (Figs. 9, 10 and table 2):

Fig. 5: Stratigraphic representation of the object in cross-section using the MiCorr application. This representation can be compared to Fig. 10.

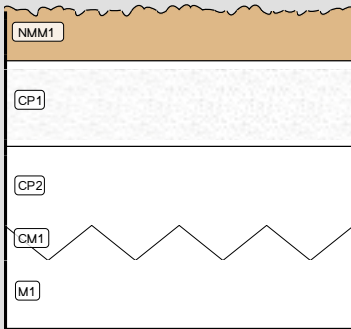
- **Inner grey layer – CP2** (up to 1 mm thick) is a translucent, compact layer and constitutes most part of the corrosion products. Corroded metal appears inside this layer as lead inclusions within a black corrosion product (Figs. 11 and 12). Sulphur has also been detected by SEM-EDX inside this layer, near the surface, where the colour turns into grey-orange (zinc sulfide or sulphates but to be confirmed, table 2).

- **Inner white layer – CP1** (up to 0.6 mm thick) is an opaque and powdery heap, occurring in different places inside inner grey layer and sometimes near the surface, as pitting corrosion. The interface between inner layers grey and white is diffuse. Localized aggregates showing a crystalline microstructure of thickness of 50 µm are located against the walls of a structural void, inside the white corrosion product (Fig. 12).

Fig. 6: Stratigraphic representation of the object in cross-section using the MiCorr application. This representation is different from Fig. 10 due to the inversion of CP1 and CP2. Furthermore, CP3 is not represented.
