MILITARY ID TAG 5668-MXX-1008-1 - ZN PB ALLOY - MODERN TIMES - FRANCE

Artefact name Military ID tag 5668-MXX-1008-1

Authors Christian. Degryny (HE-Arc CR, Neuchâtel, Neuchâtel, Switzerland) & Marie-Jeanne. Scholl (HE-Arc CR, Neuchâtel, Neuchâtel, Switzerland) & Valentin. Boissonnas (HE-Arc CR, Neuchâtel, Neuchâtel, Switzerland)

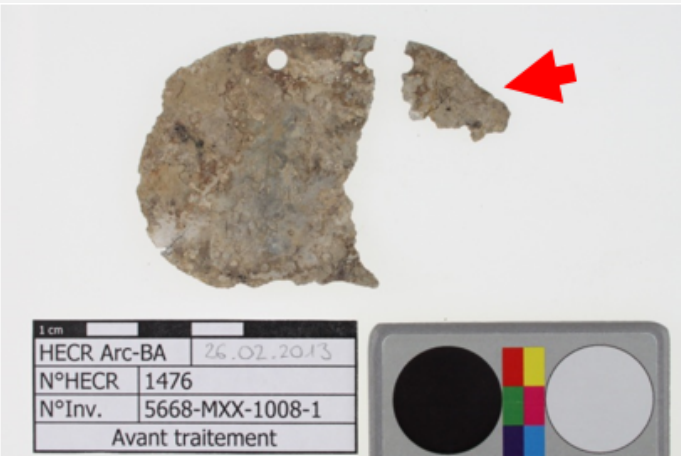
Fig. 2: Location of sample,

Description of sample	This sample was cut out of fragment b in Fig. 1. The cross-section shows the entire thickness of the plate (L = 8 mm, W= 1 mm). The corrosion goes through the whole metal thickness but a metallic core remains (Fig. 4).
Alloy	Zn Pb Alloy
Technology	Cold worked (laminated)
Lab number of sample	-
Sample location	HE-Arc CR, Neuchâtel, Neuchâtel
Responsible institution	Pôle d'Archéologie Interdépartemental Rhénan, Sélestat, Alsace
Date and aim of sampling	2013, metallography and chemical analyses

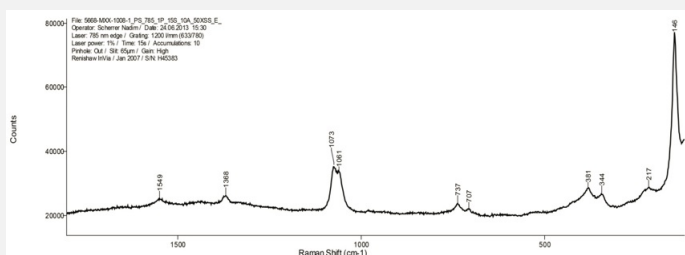
The inner grey layer has been identified by FTIR as a zinc carbonate (smithsonite), mixed with other unidentified corrosion products. Raman spectra seems to confirm it (Fig. 13). The exact composition of inner white layer is unknown. Inner white layer shows a bluish fluorescence under UV light and has been identified by FTIR as a mixture of zinc oxides and carbonates, that could be zinc hydroxycarbonates (hydrozincite). Raman spectroscopy shows also a mixture of carbonates and other corrosion products (Fig. 14). The inner black layer is a zinc carbonate as well, identified by FTIR and Raman spectroscopy (Fig. 15) appearing as a vein between layers grey and white (Fig. 8).

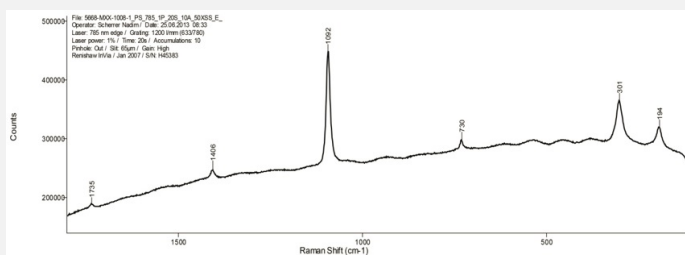
Fig. 15: Raman spectrum of inner black layer (zinc carbonate?). Settings: laser wavelength 532nm, acquisition time 10s, one accumulation, filter D2 (0.75-0.8mW), hole 500, slit 80, grating 600. Method of analysis: Raman spectroscopy, Art Technological Laboratory, Departement Conservation HKB,

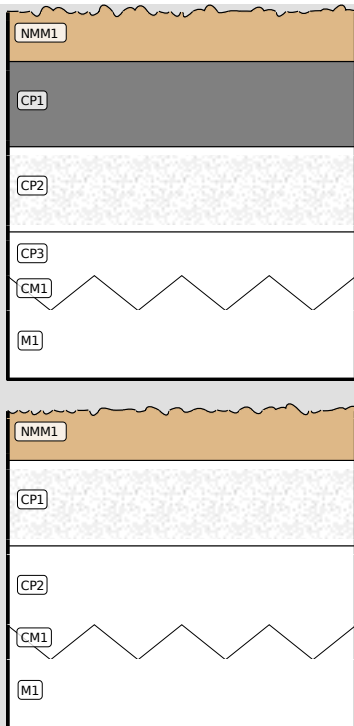
Fig. 6: Stratigraphic representation of the object in cross-section using the MiCorr application. This representation is different from Fig. 10 due to the inversion of CP1 and CP2. Furthermore, CP3 is not represented.
