SITULA EMT09-554.665 - TIN BRONZE - IRON AGE - SWITZERLAND

Artefact name	Situla EMT09-554.665
Authors	Christian. Degriigny (HE-Arc CR, Neuchâtel, Neuchâtel, Switzerland) & Marie-Jeanne. Scholl (HE-Arc CR, Neuchâtel, Neuchâtel, Switzerland) & Valentin. Boissonnas (HE-Arc CR, Neuchâtel, Neuchâtel, Switzerland)
Url	/artefacts/221/

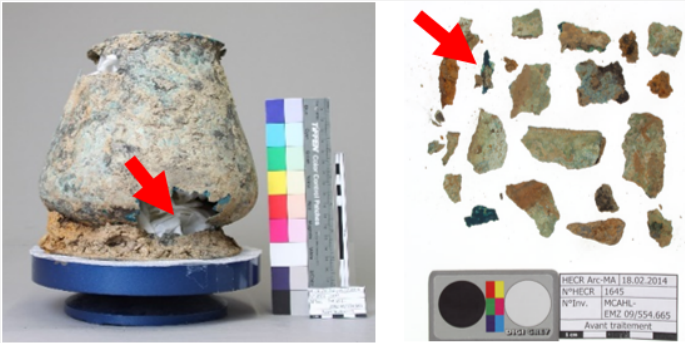
Fig. 2: Location of sampling area and sample selected from detached fragments,

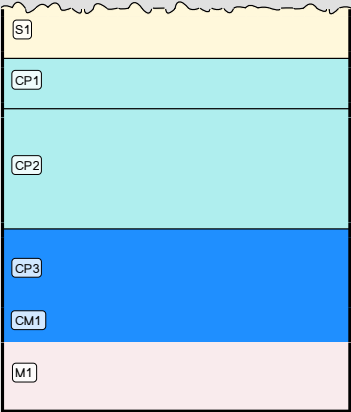
Fig. 5: Stratigraphic representation of the object in cross-section using the MiCorr application. This representation shows the exterior face and can be compared to Fig. 10 (bottom square)

Fig. 6: Stratigraphic representation of the object in cross-section using the MiCorr application. This representation shows the interior face and can be compared to Fig. 10 (top square).
