CORRODED METAL SHEET FN 655.13.01 – FE ALLOY – MODERN TIMES – SWITZERLAND

Artefact name Corroded metal sheet FN 655.13.01

Authors Marianne. Senn (EMPA, Dübendorf, Zurich, Switzerland) & Christian. Degriigny (HE-Arc CR, Neuchâtel, Neuchâtel, Switzerland)

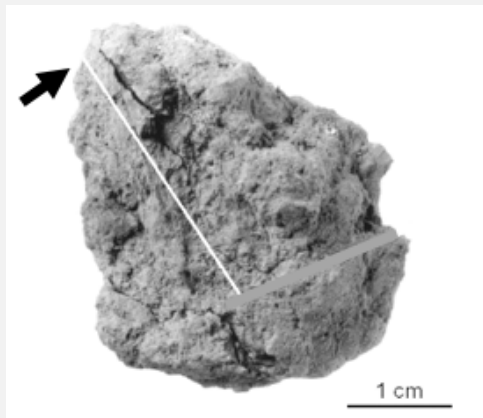
Fig. 2: Location of sampling area,

Description of sample	A longitudinal cut has been made through the sheet (Fig. 2). Large parts of the corrosion crust fell off during sampling (Fig. 3).
Alloy	Fe Alloy
Technology	Forged with final cold work
Lab number of sample	NEF 655
Sample location	Empa (Marianne Senn)
Responsible institution	Kantonsarchäologie, Dübendorf, Zurich
Date and aim of sampling	2000, metallography
