SACRIFICIAL ANODE VHS-8339 - ZN ALLOY - MODERN TIMES

Artefact name Sacrificial anode VHS-8339

Authors Marianne. Senn (EMPA, Dübendorf, Zurich, Switzerland) & Christian. Degrigny (HE-Arc CR, Neuchâtel, Neuchâtel,

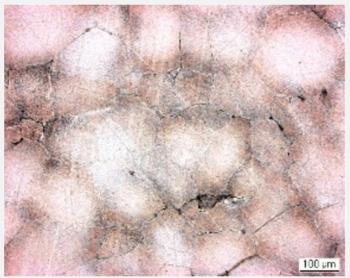
The remaining metal is an almost pure zinc alloy (Table 1). The oxygen content is not from the original alloy, but is due to secondary corrosion. The metal grains are visible without etching and present a polygonal structure (Figs. 5 and 6). The structure is recrystallised after annealing. The recrystallization of zinc alloys begins at room temperature.

Fig. 5: Micrograph of the metal sample from Fig. 3 (reversed picture, detail), unetched, bright field. Extensive intergranular corrosion is visible. The rectangle marks Fig. 7,

Extended intergranular corrosion has developed in the metal structure (Figs. 5, 6). The metal is covered by a corrosion crust that is hardly visible in bright field and which contains remnant metal (Fig. 5). On most of the sample the corrosion crust is uniform. In areas we see cracks (Fig. 7) appearing as brown lines separating the corrosion crust (Fig. 8). In bright field the corrosion crust appears grey containing dark-grey zones (Fig. 7). Under polarized light, the corrosion crust appears white with darker parts including remnant metal (Fig. 8). It contains Zn and O as well as S along some cracks (Table 2 and Fig. 9).
