SACRIFICIAL ANODE VHS-8339 - ZN ALLOY - MODERN TIMES

Sacrificial anode VHS-8339

Marianne. Senn (EMPA, Dübendorf, Zurich, Switzerland) & Christian. Degrigny (HE-Arc CR, Neuchâtel, Neuchâtel, Switzerland)

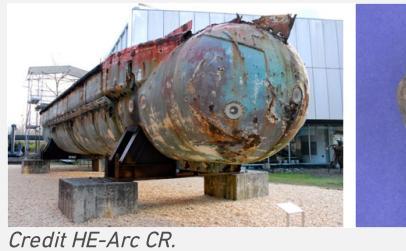
Fig. 1: The submarine and the anode (www.verkehrshaus.ch),

Description of the artefact	The artefact could be a weight or sacrificial anode of a submarine (Fig. 1). It is surrounded by a whitish brown-grey corrosion crust. The broken metal has a greyish shiny colour, whereas the metal part that is cut has a silvery appearance. Dimensions: L = 4.9cm ; WT = 95g.		
Type of artefact	Submarine part		
Origin	Submarine "Mesoscaph" from Auguste Piccard		
Recovering date	The sacrificial anodes (?) might have been added when the submarine was used in the sea.		
Chronology category	Modern Times		
chronology tpq	1970	A.D. 🗸	
chronology taq	1974	A.D. 🗸	
Chronology comment	1970_1974		
Burial conditions / environment	Outdoor atmosphere		
Artefact location	Swiss Museum of Transport, Luzern, Lucerne		
Owner	Swiss Museum of Transport, Luzern, Lucerne		
Inv. number	VHS-8339		
Recorded conservation data	Not conserved
