# CIRCULAR DOOR KNOCKER STRIKING PLATE – CU ALLOY – MODERN TIMES – SWITZERLAND

<b>Artefact name</b>	Circular door knocker striking plate
<b>Authors</b>	Marianne. Senn (EMPA, Dübendorf, Zurich, Switzerland) & Christian. Degrigny (HE-Arc CR, Neuchâtel, Neuchâtel, Switzerland)
<b>Url</b>	/artefacts/324/

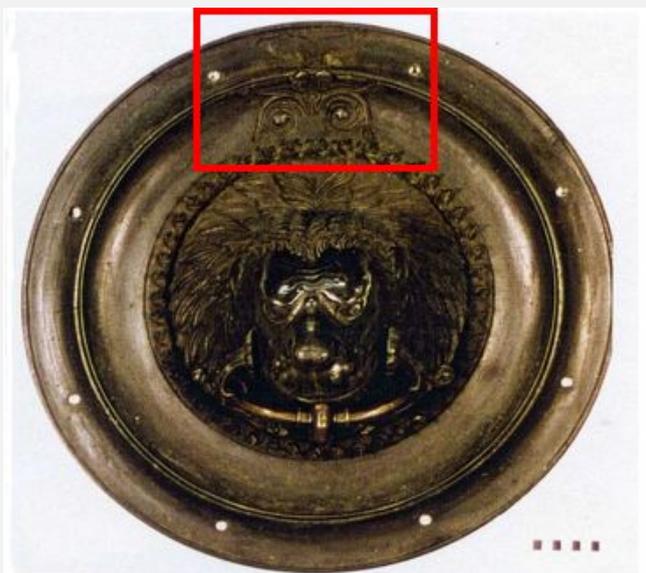
Fig. 2: Possible location of sampling area,

<b>Description of sample</b>	No information is given on where the sample has been taken. A supposed location is however illustrated in Fig. 2. The polished sample shows a well preserved metal surface with some cracks covered by a thin corrosion crust (Fig. 3).
<b>Alloy</b>	Cu Alloy
<b>Technology</b>	Rolled, annealed after cold working
<b>Lab number of sample</b>	MAH 94-156-001
<b>Sample location</b>	Musées d'art et d'histoire, Genève, Geneva
<b>Responsible institution</b>	Musées d'art et d'histoire, Genève, Geneva
<b>Date and aim of sampling</b>	1994, metallography and presence or not of a gilding treatment
