CIRCULAR DOOR KNOCKER STRIKING PLATE - CU ALLOY - MODERN TIMES - SWITZERLAND

Artefact name Circular door knocker striking plate

Authors Marianne. Senn (EMPA, Dübendorf, Zurich, Switzerland) & Christian. Degrigny (HE-Arc CR, Neuchâtel, Neuchâtel,

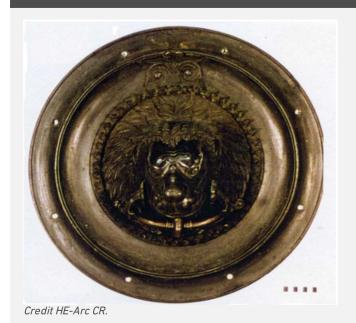
Fig. 1: Copper alloy circular base from a door knocker (after Benoît, 1994),

Description of the artefact Circular base no 2 (from a set of two) of a door knocker with a protruding lion head holding a hinge in his

fangs, Ø.ext = 64cm. The circular base is covered by a gilded (?) decorative relief (Fig. 1, Benoit, 1994, 6).

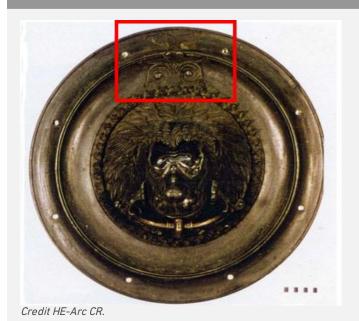
Fig. 2: Possible location of sampling area,
