## SITULA EMT09-554.665 – TIN BRONZE – IRON AGE – SWITZERLAND

<b>Artefact name</b>	Situla EMT09-554.665
<b>Authors</b>	Christian. Degriigny (HE-Arc CR, Neuchâtel, Neuchâtel, Switzerland) & Marie-Jeanne. Scholl (HE-Arc CR, Neuchâtel, Neuchâtel, Switzerland) & Valentin. Boissonnas (HE-Arc CR, Neuchâtel, Neuchâtel, Switzerland)
<b>Url</b>	/artefacts/340/

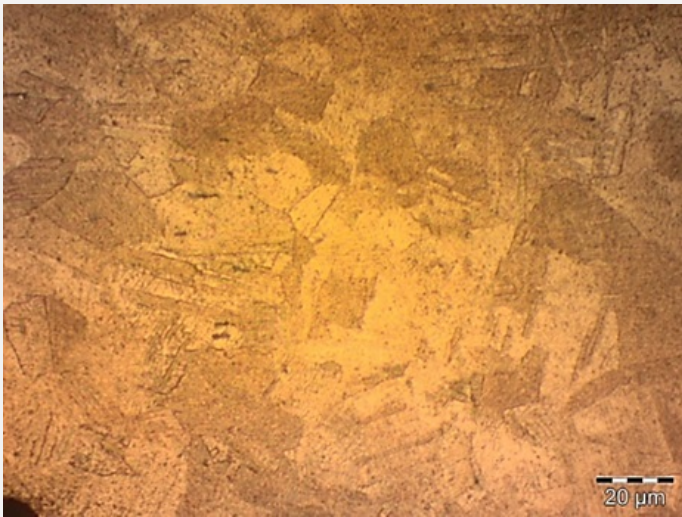
The remaining metal is a dense tin bronze (Fig. 7, Table 1), showing no inclusion. In bright field, the etched alloy shows a structure principally consisting of polygonal alpha phase grains (Fig. 8). Some of the grains include twin lines (Fig. 9). The presence of strain lines (slip lines) indicates a final cold work without annealing (Fig. 9).

Fig. 9: Micrograph of the selected area of Fig. 8, etched, bright field, 500x. The grains show both twin and strain lines,
