SITULA EMT09/554.665 – TIN BRONZE – IRON AGE – SWITZERLAND

Artefact name	Situla EMT09/554.665
Authors	Christian. Degriigny (HE-Arc CR, Neuchâtel, Neuchâtel, Switzerland) & Marie-Jeanne. Scholl (HE-Arc CR, Neuchâtel, Neuchâtel, Switzerland) & Valentin. Boissonnas (HE-Arc CR, Neuchâtel, Neuchâtel, Switzerland)
Url	/artefacts/340/

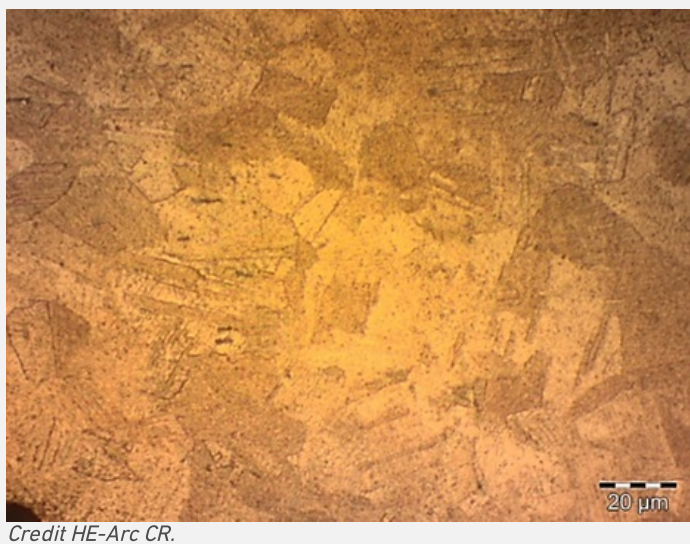
The remaining metal is a dense tin bronze (Fig. 7, Table 1), showing no inclusion. In bright field, the etched alloy shows a structure principally consisting of polygonal alpha phase grains (Fig. 8). Some of the grains include twin lines (Fig. 9). The presence of strain lines (slip lines) indicates a final cold work without annealing (Fig. 9).

Fig. 9: Micrograph of the selected area of Fig. 8, etched, bright field, 500x. The grains show both twin and strain lines,

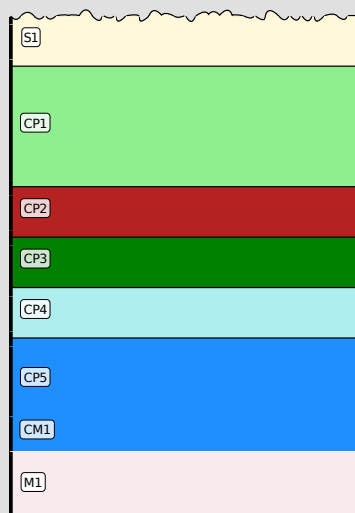
There are 2 stratigraphies (Fig. 5 corresponding to the interior face of the situla and Fig. 6 to its exterior face). The strata are similar in composition but their coding is different: CP1 to CP3 in Fig. 5 correspond to CP3 to CP5 in Fig. 6. Since the stratigraphy of Fig. 6 is more complete, the composition of each of its strata is given below.

The inner layers (CP3-CP5) are Sn and O-rich and depleted in Cu (Table 2). The outer layers (CP1 and CP2) are Cu and O-rich, contain no Sn, and are contaminated with Ca, Si, Al and Fe coming from the soil (Fig. 12). The colour of the corrosion crust varies according to the content of Sn (the more Sn, the darker green or blue the corrosion). FTIR on the inner blue (CP5 and Fig. 14) and outer green (CP1 and Fig. 15) layers were difficult to interpret. Only malachite could be identified in both cases. XRD spectra could not be interpreted because of the deficiency of peaks.

Fig. 6: Stratigraphic representation of the object in cross-section using the MiCorr application. This representation shows the interior face and can be compared to Fig. 10 (top square).

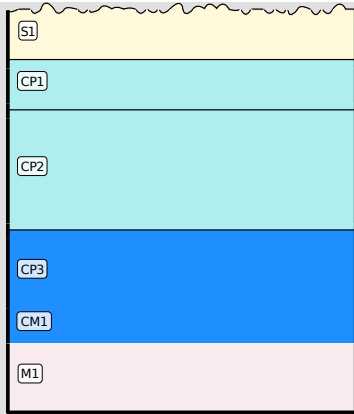
Fig. 5: Stratigraphic representation of the object in cross-section using the MiCorr application. This representation shows the exterior face and can be compared to Fig. 10 (bottom square)
