# FUNERAL MASK IVC 11595 – CU/AG, WITH SURFACE ENRICHMENT (AG)

**Artefact name** Funeral mask Ivc 11595

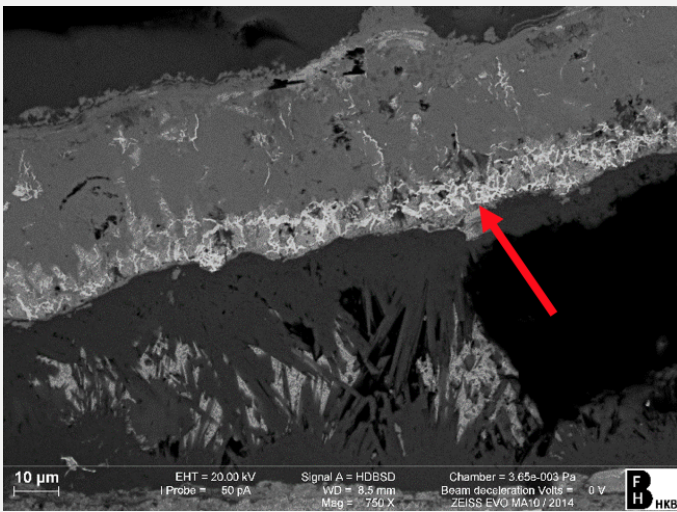
Fig. 8: SEM image of a partially refilled structural void with a silver-, copper- and mercury-rich layer (red arrow),

The silver sulphide (HgS, cinnabar, Fig. 14), present as a red pigment on the silver surface, could have been reduced through an electrochemical process in the presence of chlorides (Keune, K. (2005)). The released sulfur recombined with the silver to form black silver sulphide. Above that layer a porous mercury- and silver rich stratum has formed (see Hg & Ag on cartography Fig. 9). It remains unclear if the limitos is located in the silver enriched surface or within this silver-mercury compound (Fig. 8).

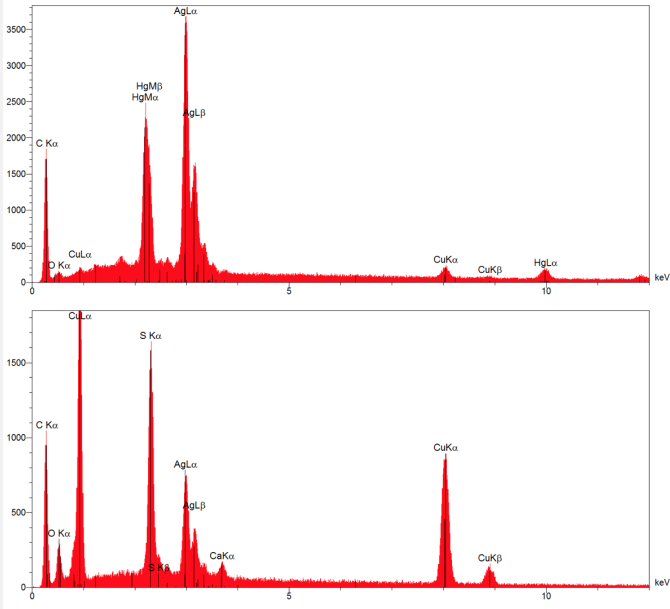
Figs. 11a and b: EDS analysis of the layer that appears light grey under polarized light, situated below the red layer (Fig.

4). Method of analysis: SEM-EDS, Lab of Electronic Microscopy and Microanalysis, IMA (Néode), HEI Arc,

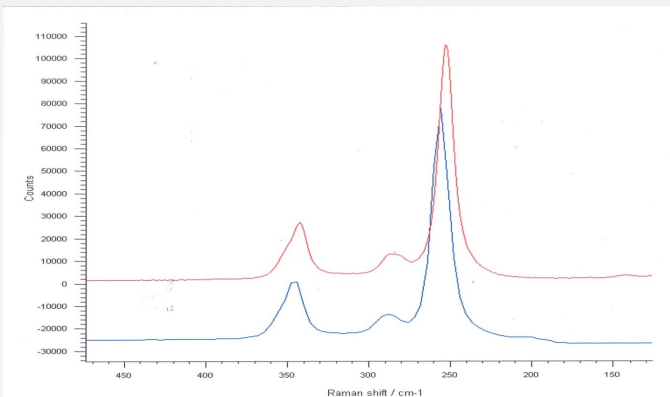
Fig. 14: Raman analysis of the red pigment on the surface (red line) and the references for cinnabar (blue line). Method of analysis: Raman spectroscopy, HKB,

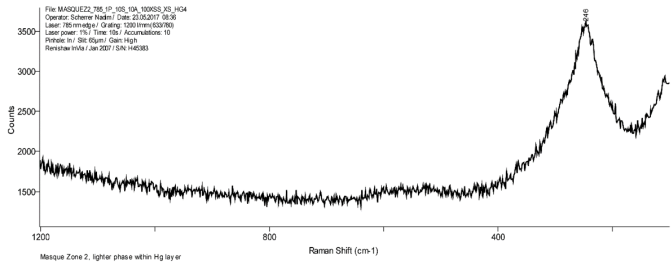
Fig. 15: Raman analysis of the mercury compounds from the cross section. Method of analysis: Raman spectroscopy, HKB,
