# FUNERAL MASK IVC 11595 – CU/AG, WITH SURFACE ENRICHMENT (AG)

**Artefact name** Funeral mask Ivc 11595

Peru, north coast

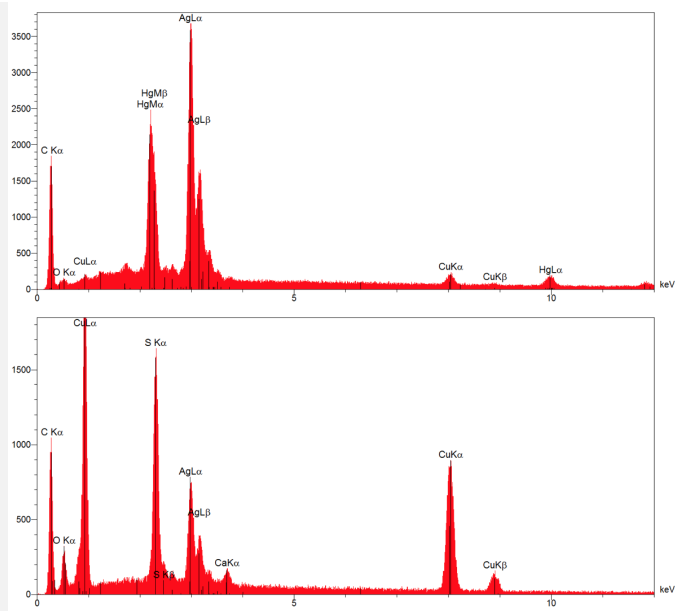
Figs. 11a and b: EDS analysis of the layer that appears light grey under polarized light, situated below the red layer (Fig.

4). Method of analysis: SEM-EDS, Lab of Electronic Microscopy and Microanalysis, IMA (Néode), HEI Arc,
