# CORRODED METAL SHEET FN 655.13.01 - FE ALLOY - MODERN TIMES - SWITZERLAND

**Artefact name** Corroded metal sheet FN 655.13.01

**Authors** Marianne. Senn (EMPA, Dübendorf, Zurich, Switzerland) & Christian. Degrigny (HE-Arc CR, Neuchâtel, Neuchâtel, Switzerland)

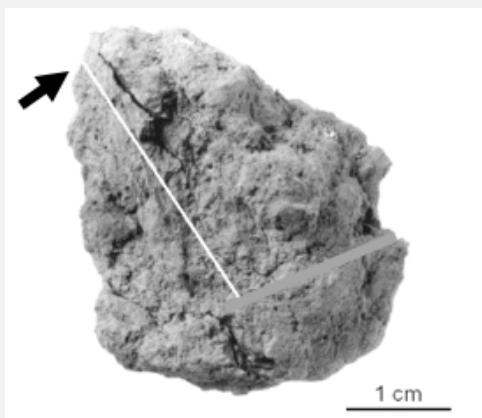
Fig. 2: Location of sampling area,

A longitudinal cut has been made through the sheet (Fig. 2). Large parts of the corrosion crust fell off during sampling (Fig. 3).
