SACRIFICIAL ANODE VHS-8339 - ZN ALLOY - MODERN TIMES

Artefact name Sacrificial anode VHS-8339

Authors Marianne. Senn (EMPA, Dübendorf, Zurich, Switzerland) & Christian. Degrigny (HE-Arc CR, Neuchâtel, Neuchâtel,

Origin Submarine "Mesoscaph" from Auguste Piccard

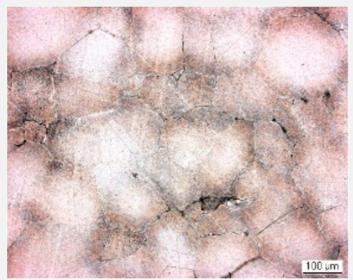
The remaining metal is an almost pure zinc alloy (Table 1). The oxygen content is not from the original alloy, but is due to secondary corrosion. The metal grains are visible without etching and present a polygonal structure (Figs. 5 and 6). The structure is recrystallised after annealing. The recrystallization of zinc alloys begins at room temperature.

Fig. 5: Micrograph of the metal sample from Fig. 3 (reversed picture, detail), unetched, bright field. Extensive intergranular corrosion is visible. The rectangle marks Fig. 7,

Extended intergranular corrosion has developed in the metal structure (Figs. 5, 6). The metal is covered by a corrosion crust that is hardly visible in bright field and which contains remnant metal (Fig. 5). On most of the sample the corrosion crust is uniform. In areas we see cracks (Fig. 7) appearing as brown lines separating the corrosion crust (Fig. 8). In bright field the corrosion crust appears grey containing dark-grey zones (Fig. 7). Under polarized light, the corrosion crust appears white with darker parts including remnant metal (Fig. 8). It contains Zn and O as well as S along some cracks (Table 2 and Fig. 9).
